# Pumicestone Passage Shellfish Reef Habitat Restoration Project – 9 Month Invertebrate Monitoring

**OzFish Unlimited**

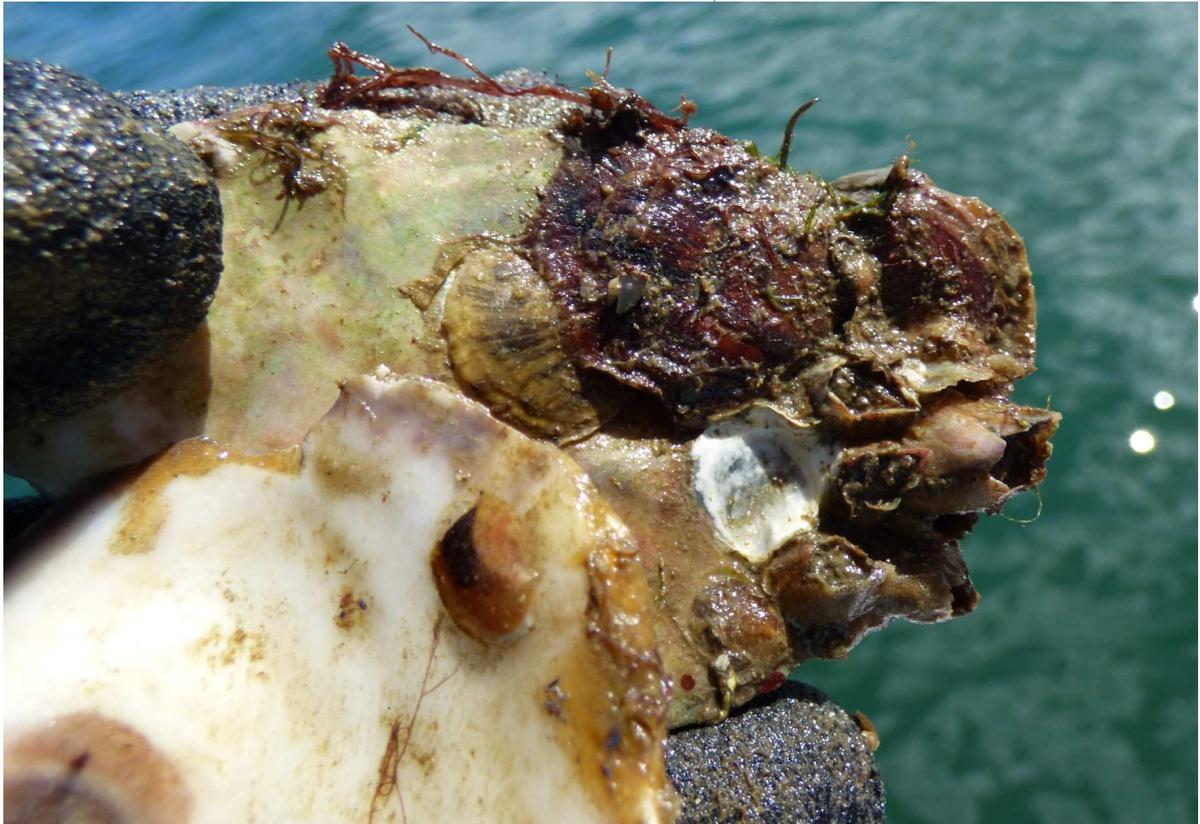
**Figure 5.** Evidence of natural *S. glomerata* spatfall on oyster shells collected 9 months post-deployment from a subtidal reef module in Pumicestone Passage.

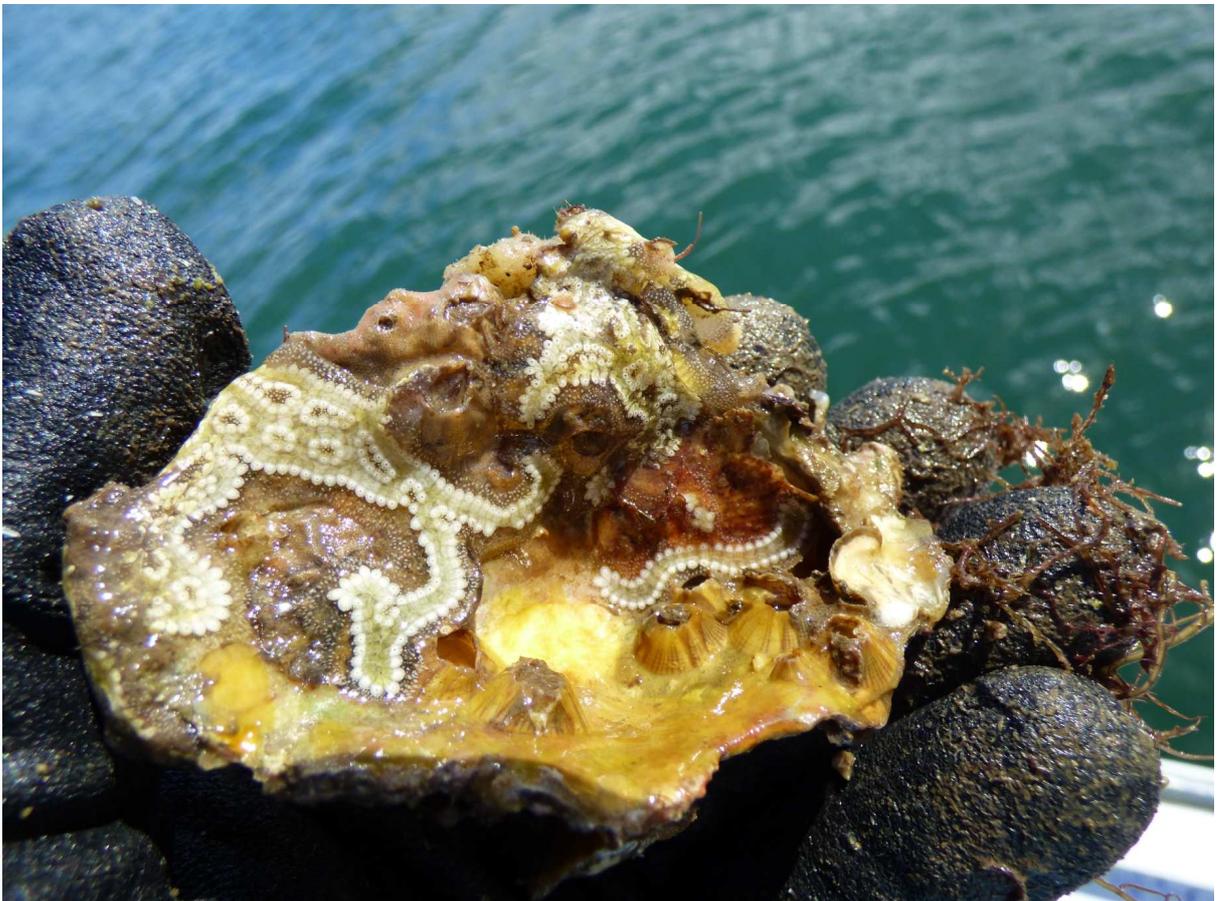
**Figure 6.** Colonisation of an oyster shell by colonial tunicates, corraline algae and barnacles after 9 months deployment on a subtidal reef module in Pumicestone Passage.

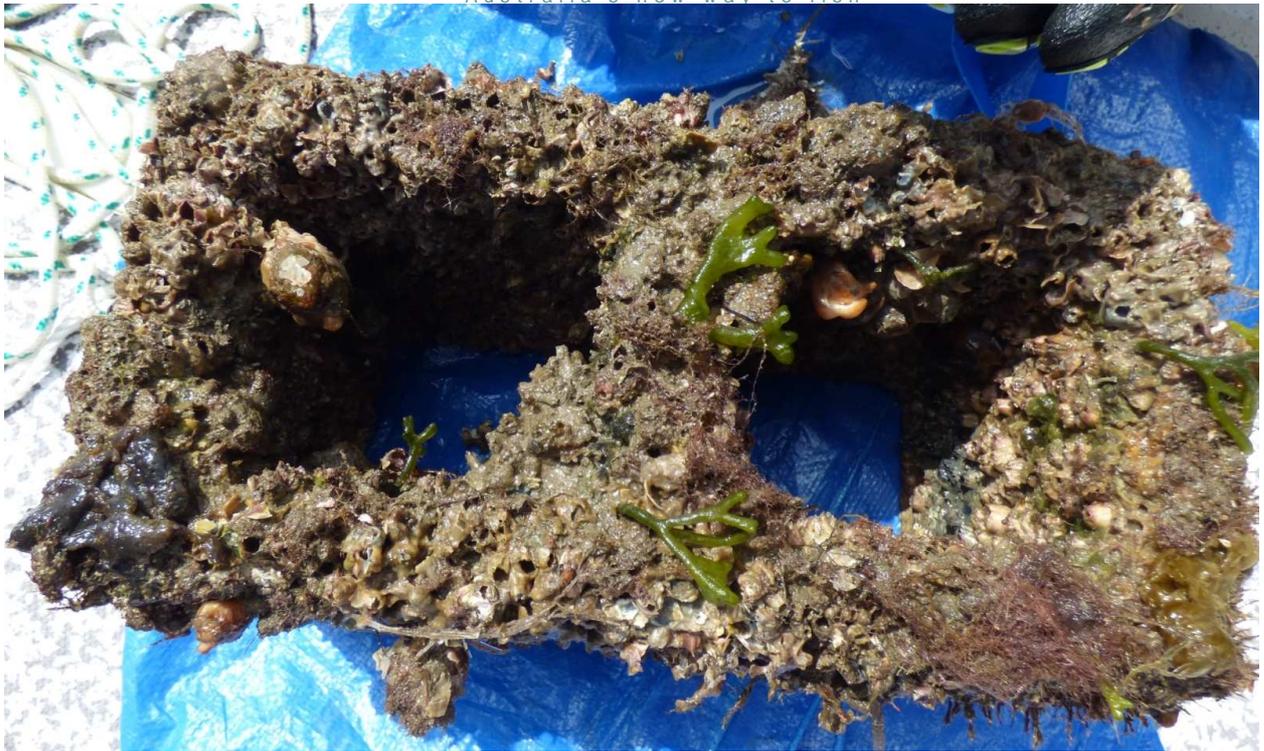
There was evidence of users anchoring in the reef area as one lost anchor was found on crate reef #1, and many of the besser blocks used as fences for patch reefs 9 and 16 were dragged several meters away and scattered over the bottom. All of the besser blocks observed had heavy growth from barnacles and reef forming invertebrates. For example, a single besser block found isolated on the bottom several meters away from its presumed original location on patch reef#9 was retrieved and examined (Figure 7). The exterior was heavily fouled with barnacles, corraline algae, and several types of brown and green macroalgae, while the interior of the block contained 9 Sydney rock oysters, 3 of which were alive and 6 dead (33% survival). Inside and adjacent to the oysters were 2 Palaemonid shrimp (*Palaemon serenus*) (Figure 8), Caridean snapping shrimp (*Alpheus* sp.) 7 small (10 mm carapace width) black crabs (Xanthidae), 1 larger portunid crab (*Charybdis* sp., 70 mm carapace width, Figure 9), and 2 nudibranchs amongst 28 sea squirts (*Pyura* sp.) and dense corraline algae. The concrete besser blocks used as fences around two of the three patch reefs thus provided additional valuable reef substrate, but because of anchor damage they appear too small to effectively fulfill their primary role as fences to retain shell. The oyster reef balls used around the third patch reef (#2) remained in place.

**Figure 7.** Condition of a single besser block found isolated on the bottom several meters away from patch reef#9. Dense growth of barnacles, coralline algae, and several types of brown and green macroalgae are evident externally.

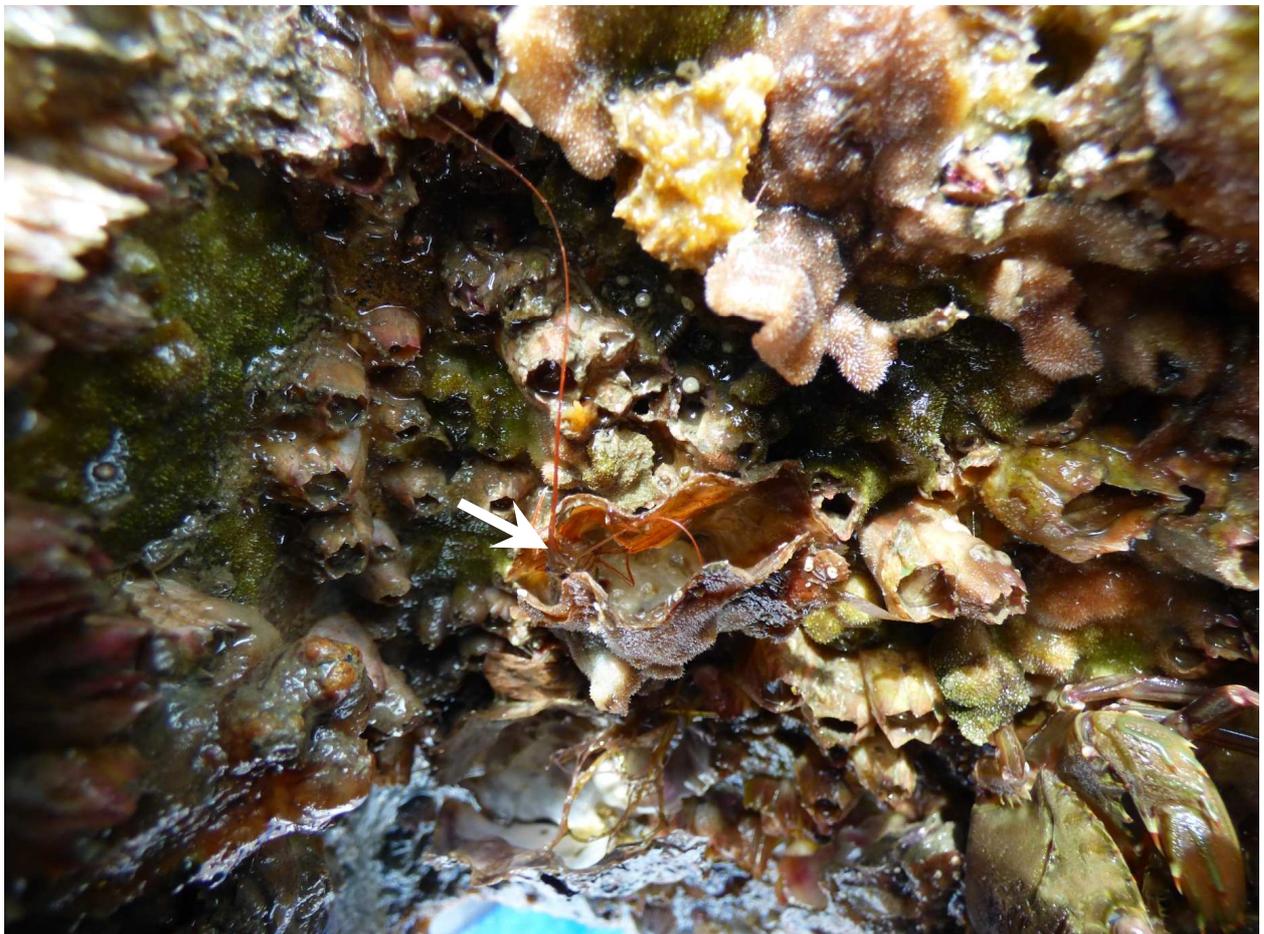
**Figure 8.** Palaemonid shrimp (arrow) hiding inside a dead oyster shell inside the besser block shown in figure 5. A portunid crab is also visible in the bottom right of the photo.

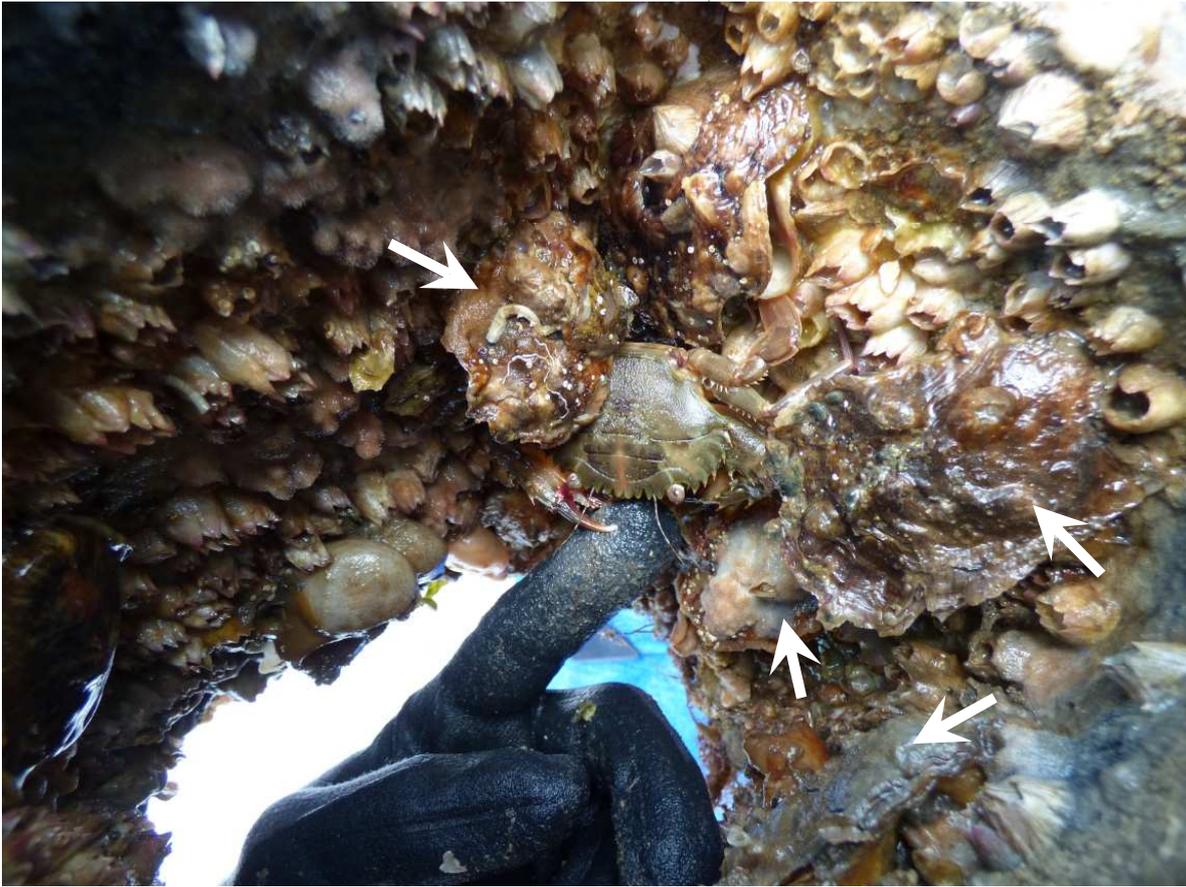
**Figure 9.** A portunid crab (*Charybdis* sp.) hiding amongst dead and live Sydney rock oyster (*S. glomerata*) shells (arrows) recruited inside the besser block shown in figure 5.

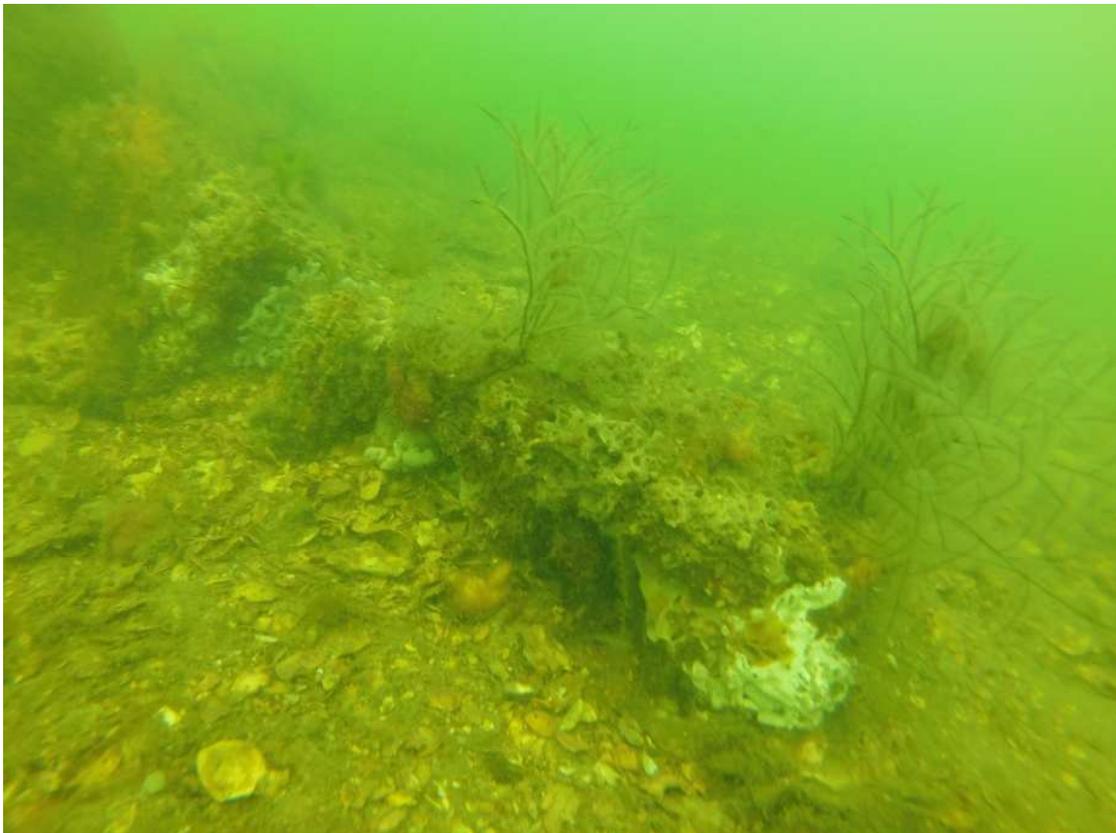
The condition of the 2 patch reefs that used besser blocks was rated as poor. Only patch reef #2 (the only patch reef surrounded by the heavier, more stable oyster reef balls) was rated in good condition (Table 1, Appendix 1). For patch reefs #9 and 16, there was evidence of sedimentation along the edges especially where besser blocks had been displaced by anchors (Figure 10, Appendix 1). The condition of patch reef #4 is currently unknown as it could not be located in the time available.

**Figure 10.** Besser block fence surrounding patch reef #16, showing sediment infilling around the edge of the reef where the integrity of the fence was disturbed by anchors.

Observations by divers together with underwater photographs (see Appendix 1) confirmed that anchor damage and sedimentation were both problematic, especially in patch reefs which used besser blocks as fence material. Anchor damage is likely to be greatly reduced if boating users in the immediate vicinity of the reefs could be warned by signage not to anchor in the restoration area. Sedimentation effects were evident along the edges of most of the reefs regardless of configuration. For the patch reefs, this "edge effect" problem could possibly be reduced by increasing the area and height of the shell piles (from c. 2 x 2 meters and 40-50 cm to at least 4 x 4 meters and 60-75 cm high) and using a more robust "fence" system around the patch reefs to retain shell and help reduce anchor damage.

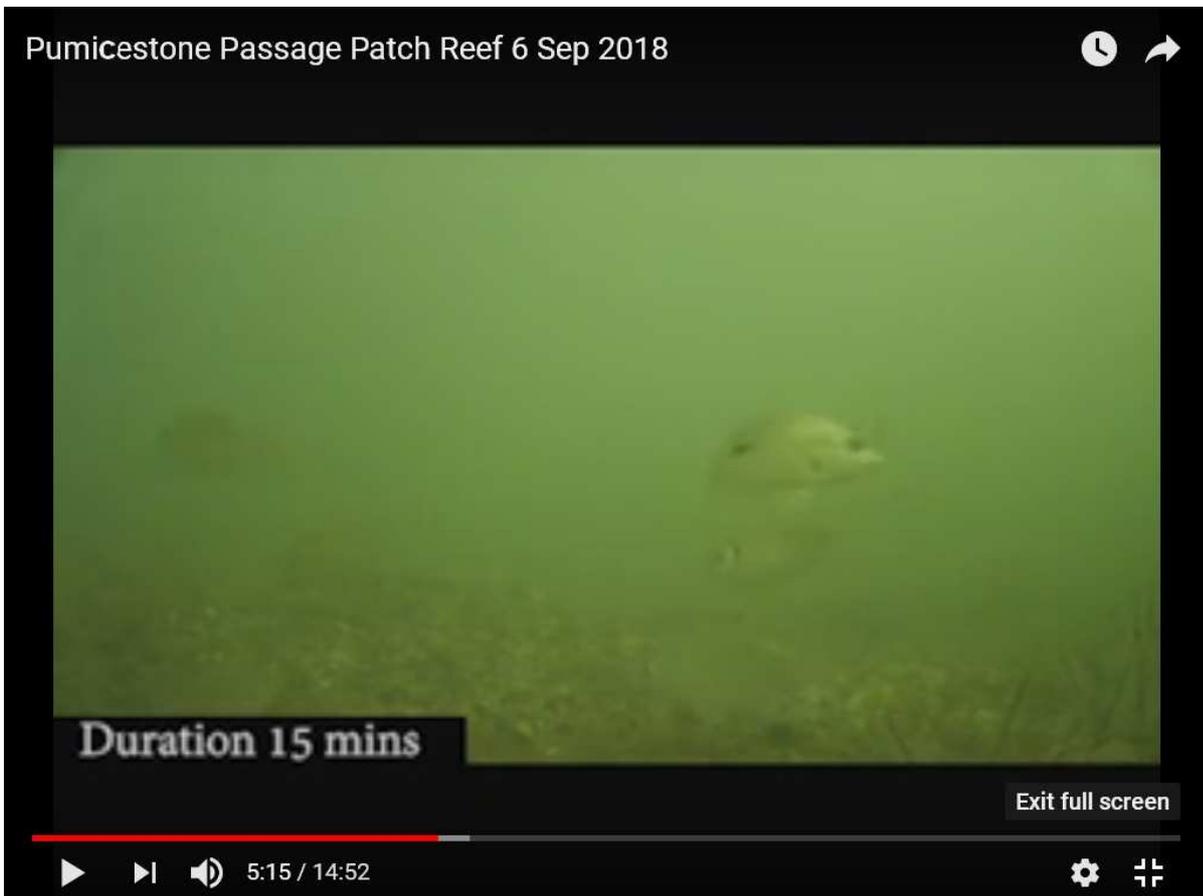
**Figures 11 and 12.** Before and after comparison of benthic condition. **Figure 11** (above) shows muddy bottom near end of Transect #1, in Jan 2017. Figure 12 (below) Patch reef #16, near same location, 6 Sept 2018, large numbers of fish are evident browsing on the oyster shell substrate.

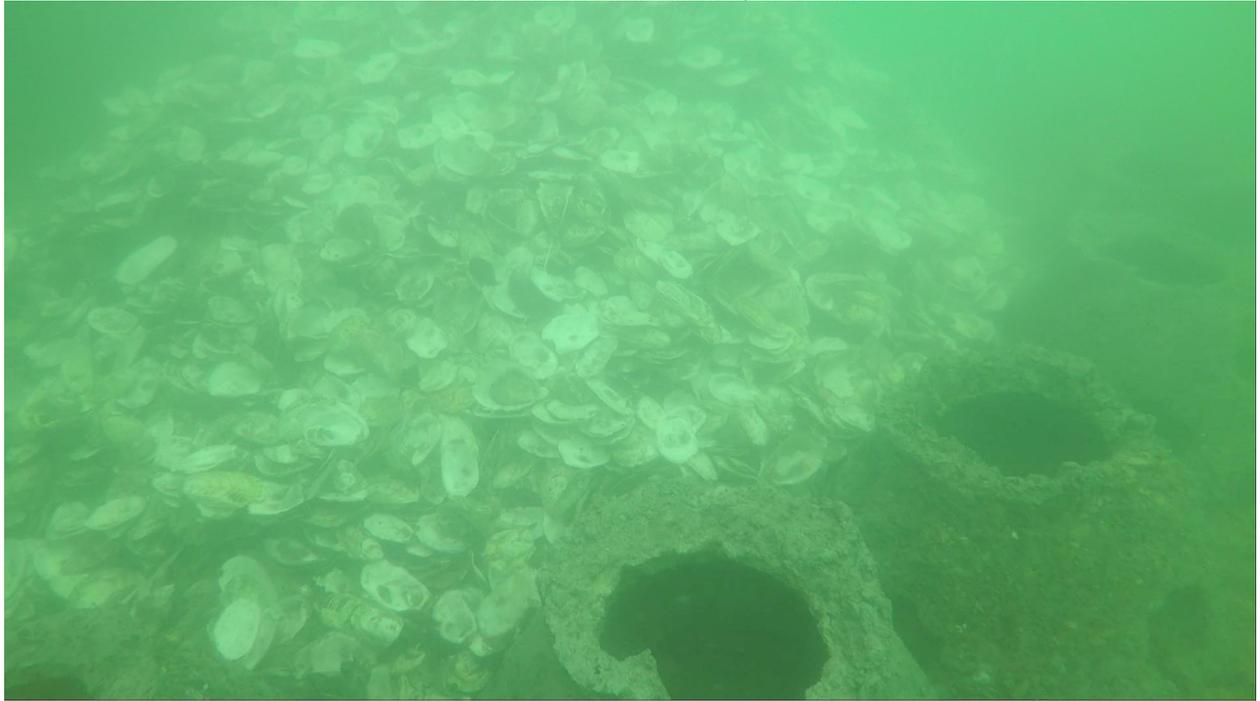
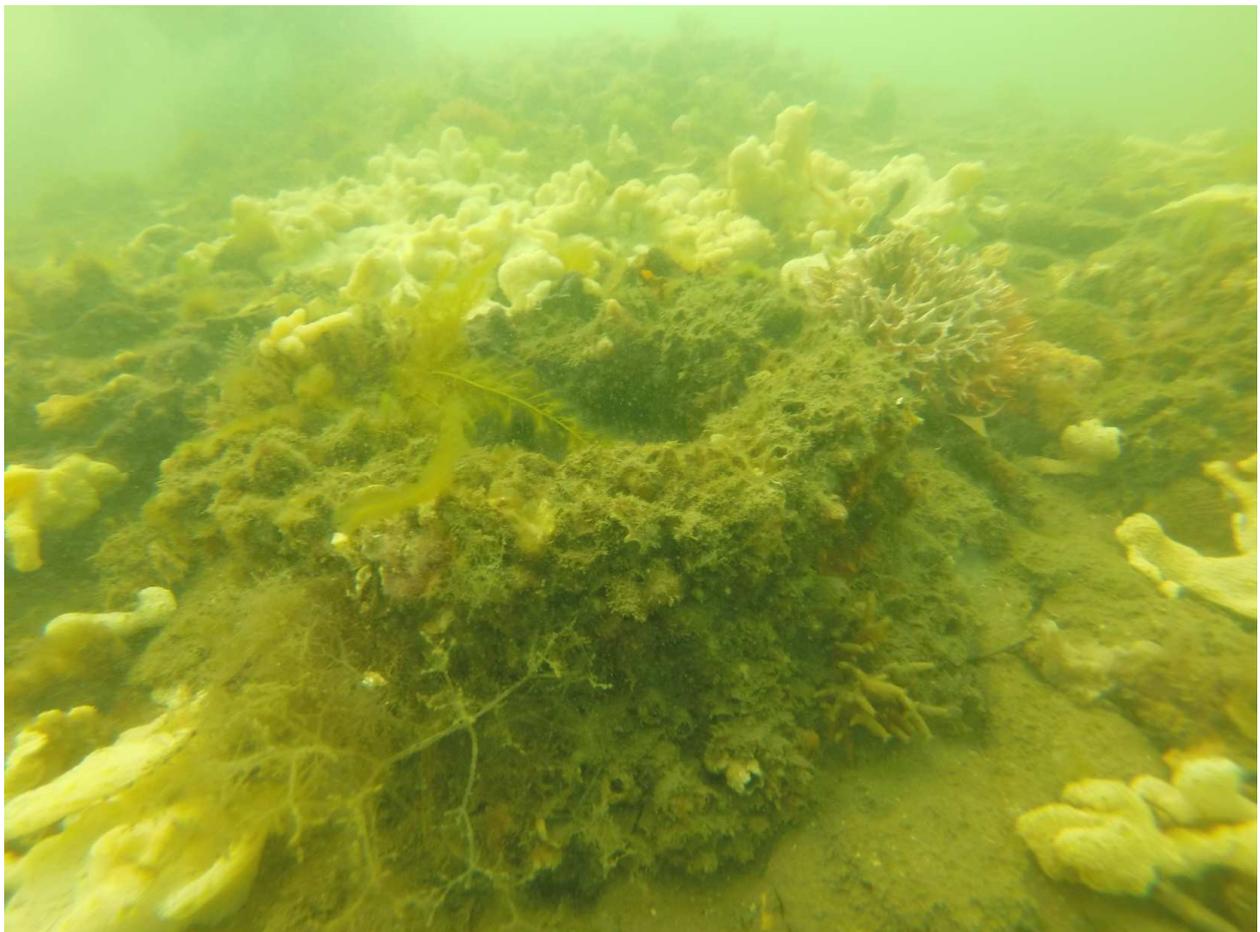
**Figures 13 and 14.** Before and after comparison of patch reef #2. **Figure 13** (above) photo taken immediately after deployment, Dec 2017. **Figure 14** (below), photo on 6 Sept 2018, note prolific sponge/soft coral growth on oyster reef balls and also over shells.

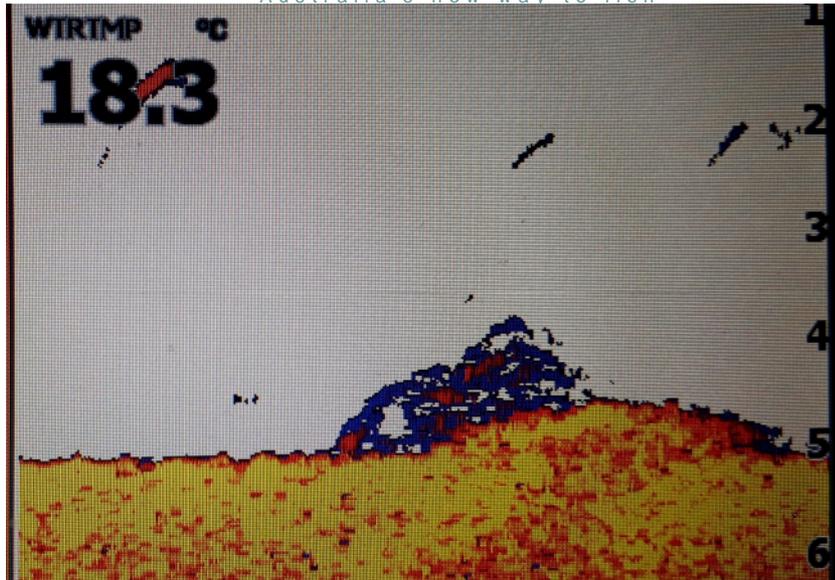
**Figure 15.** Sounder screenshot in May 2018 of patch reef #9 with browsing fish evident.

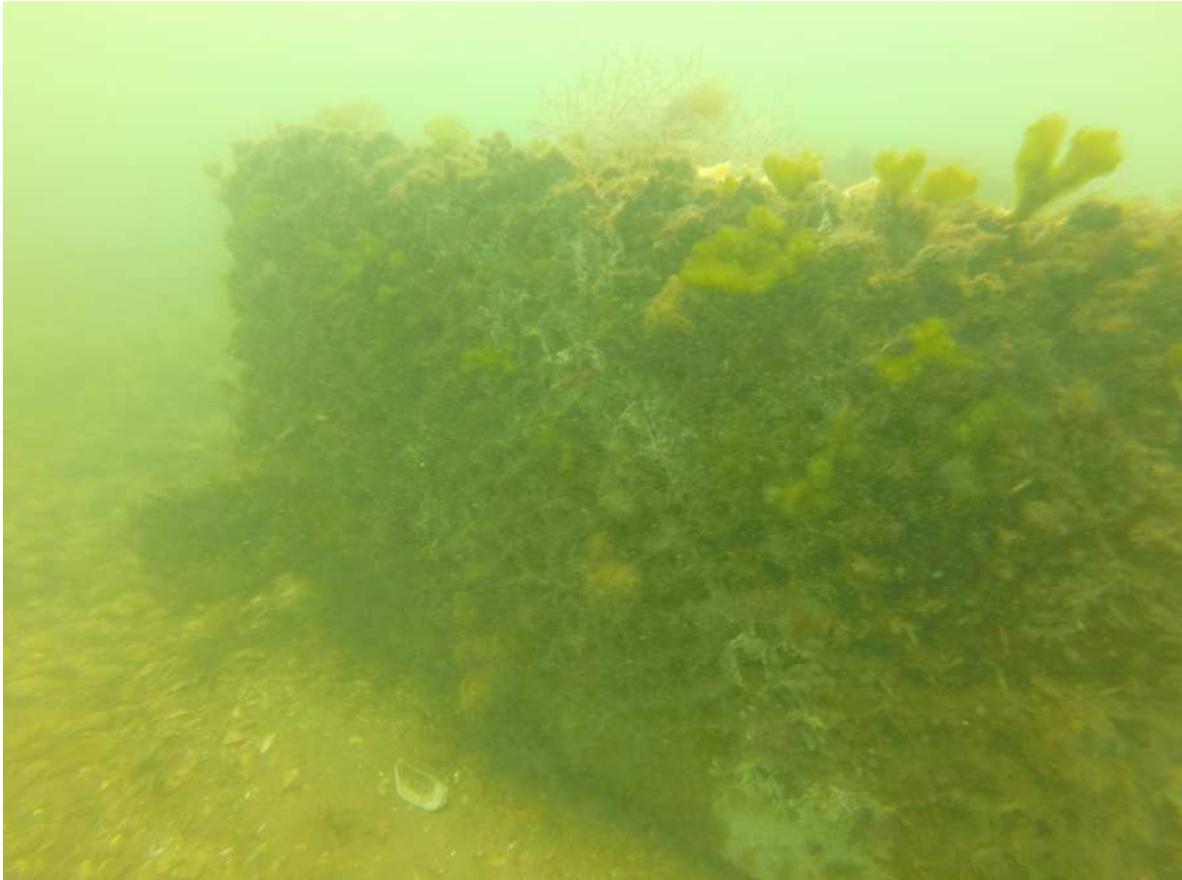
Reef Module #1 – Crate (wire cage) with dead shell (covered with mesh). Side 1.

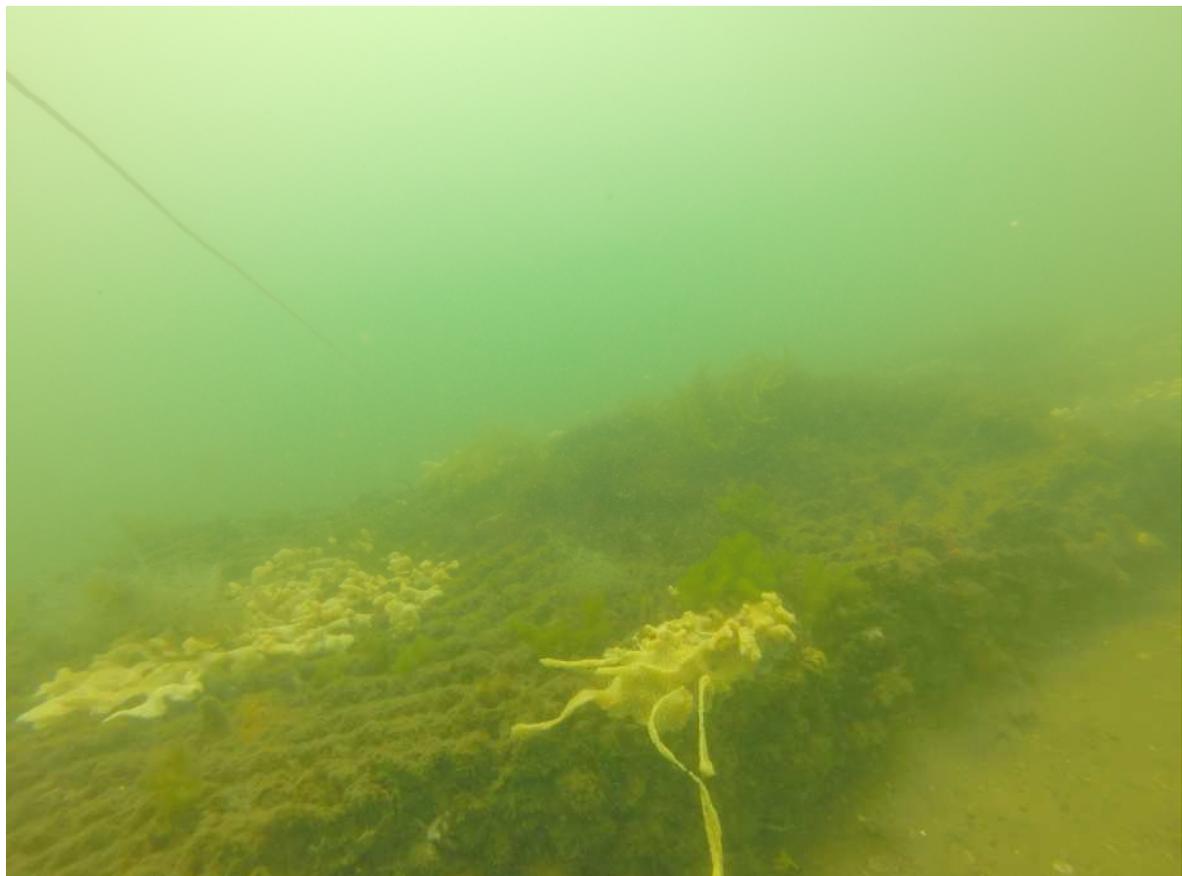
Reef Module #1 – Crate (wire cage) with dead shell (covered). Note sedimentation (right).  
2.

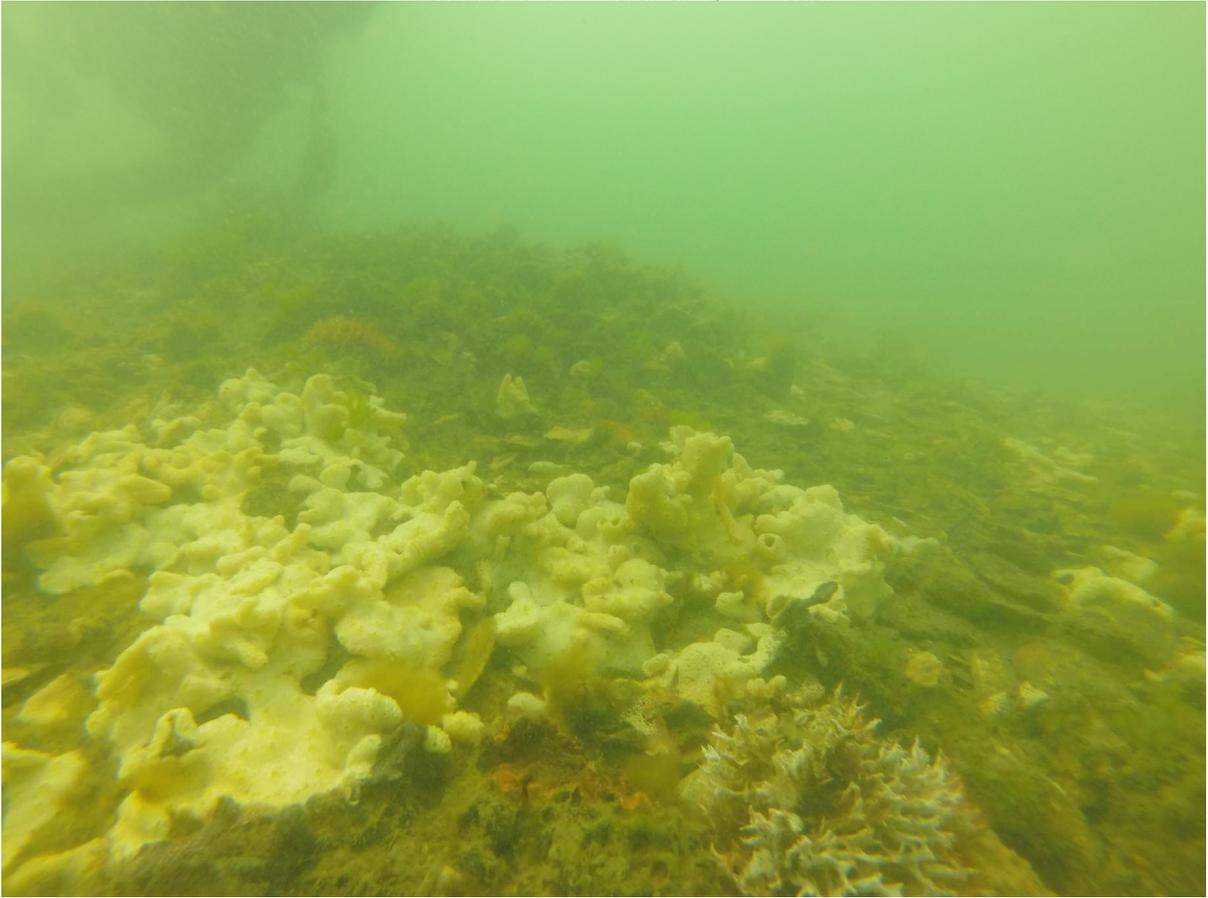
Reef Module #2 – Patch reef with dead shell. Note lack of sedimentation.

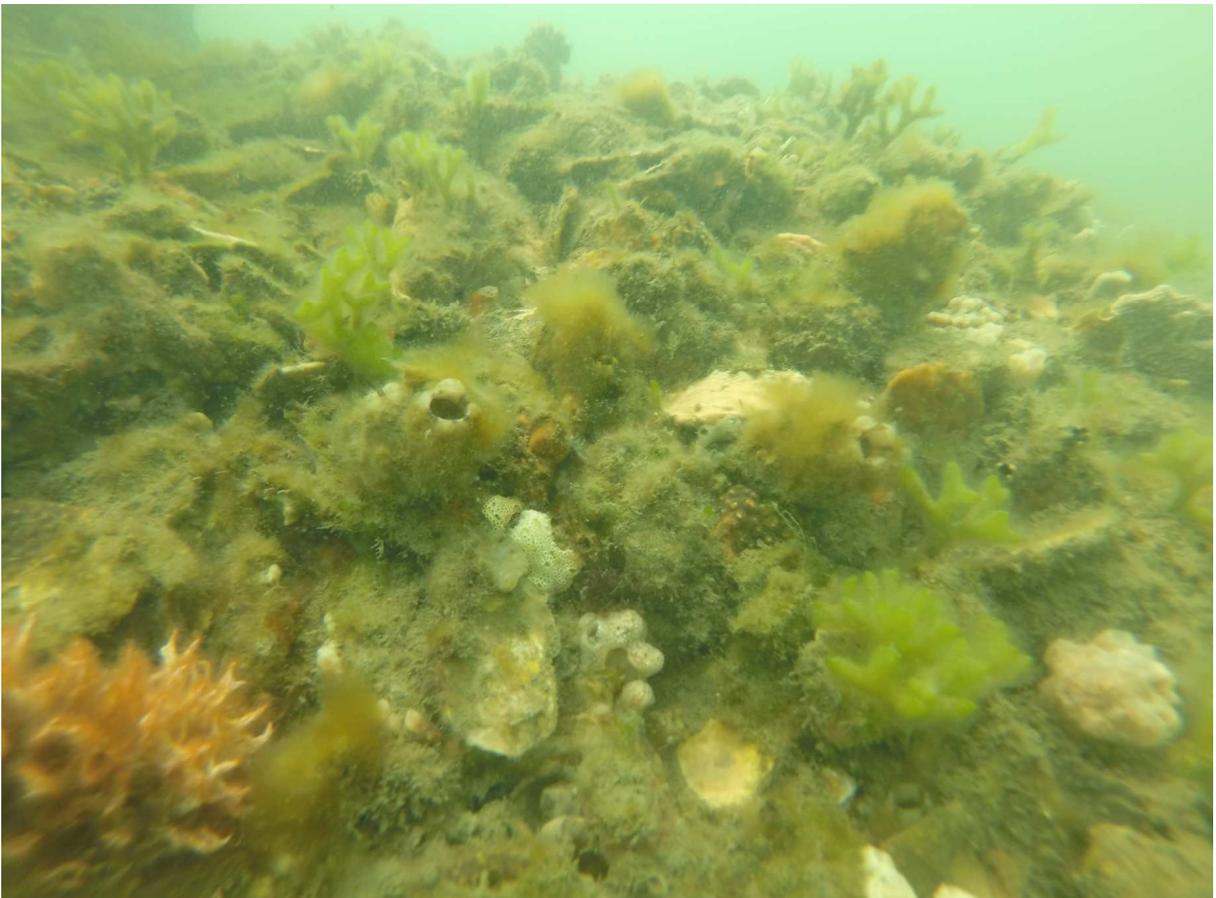
Reef Module #2 – Patch reef with dead shell. Closeup of invertebrate colonization of shells.

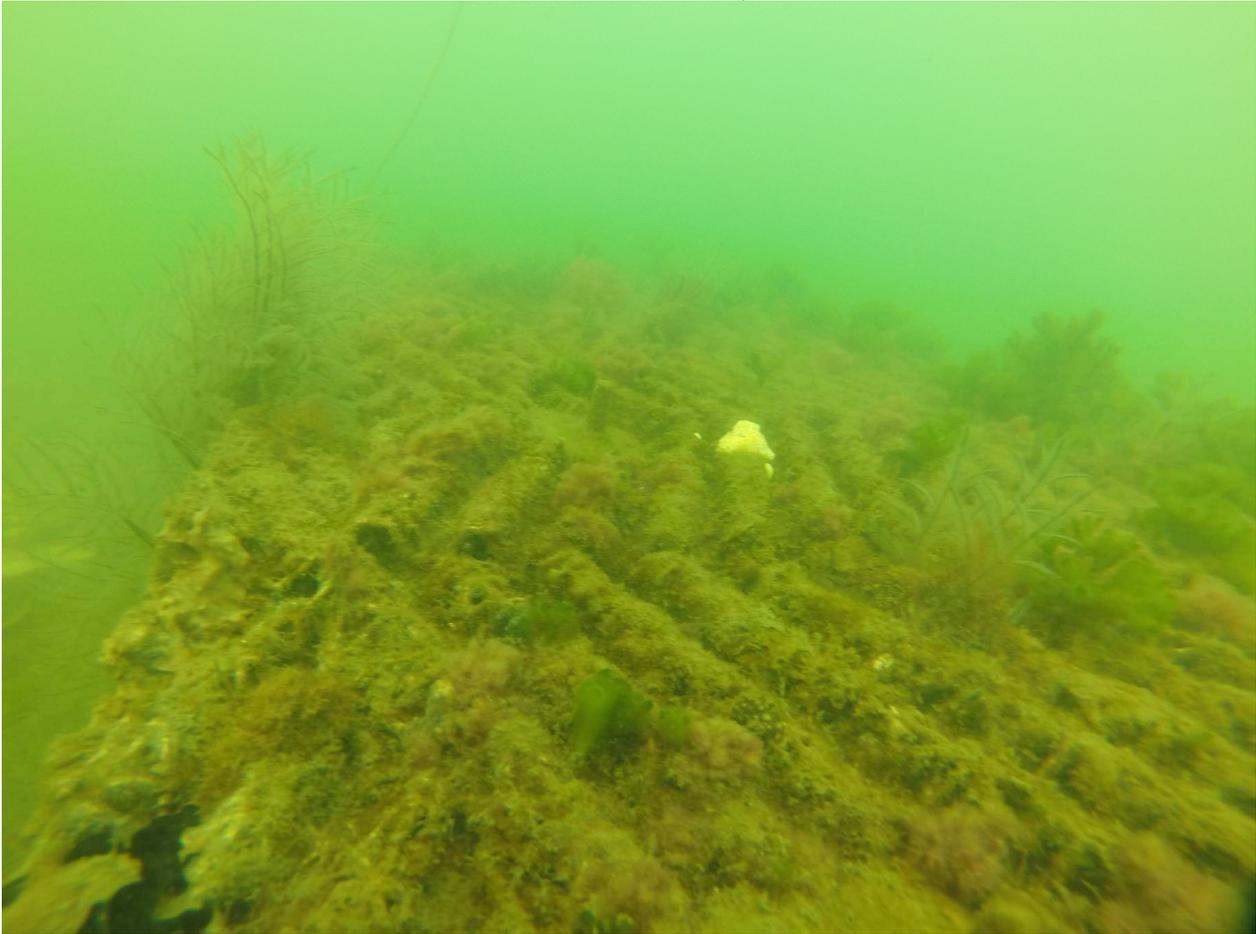
Reef Module #5 – BESE module. Top of module showing macroalgal/invertebrate growth.

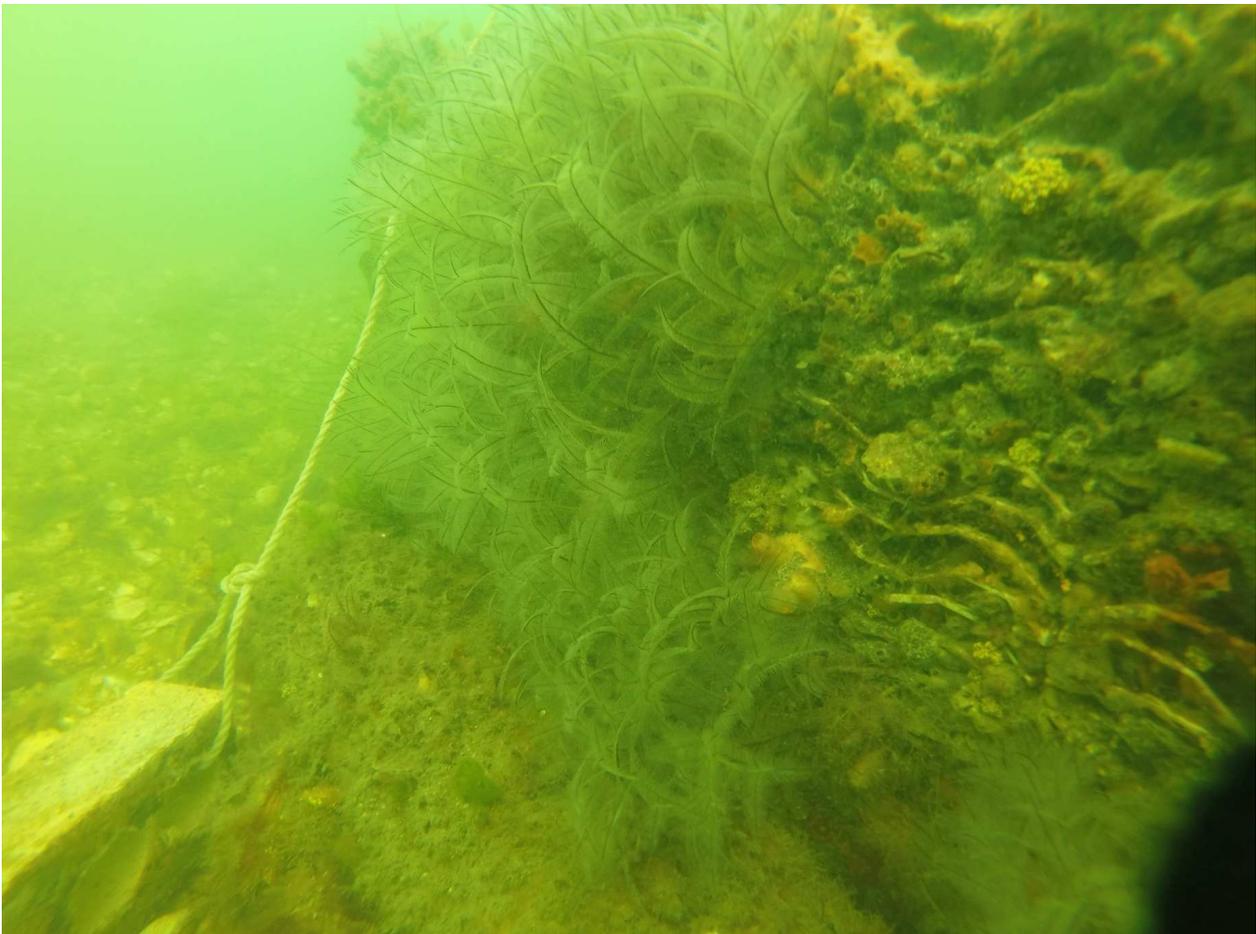
Reef Module #5 – BESE module. Edge showing temporary marker anchor and reef growth.

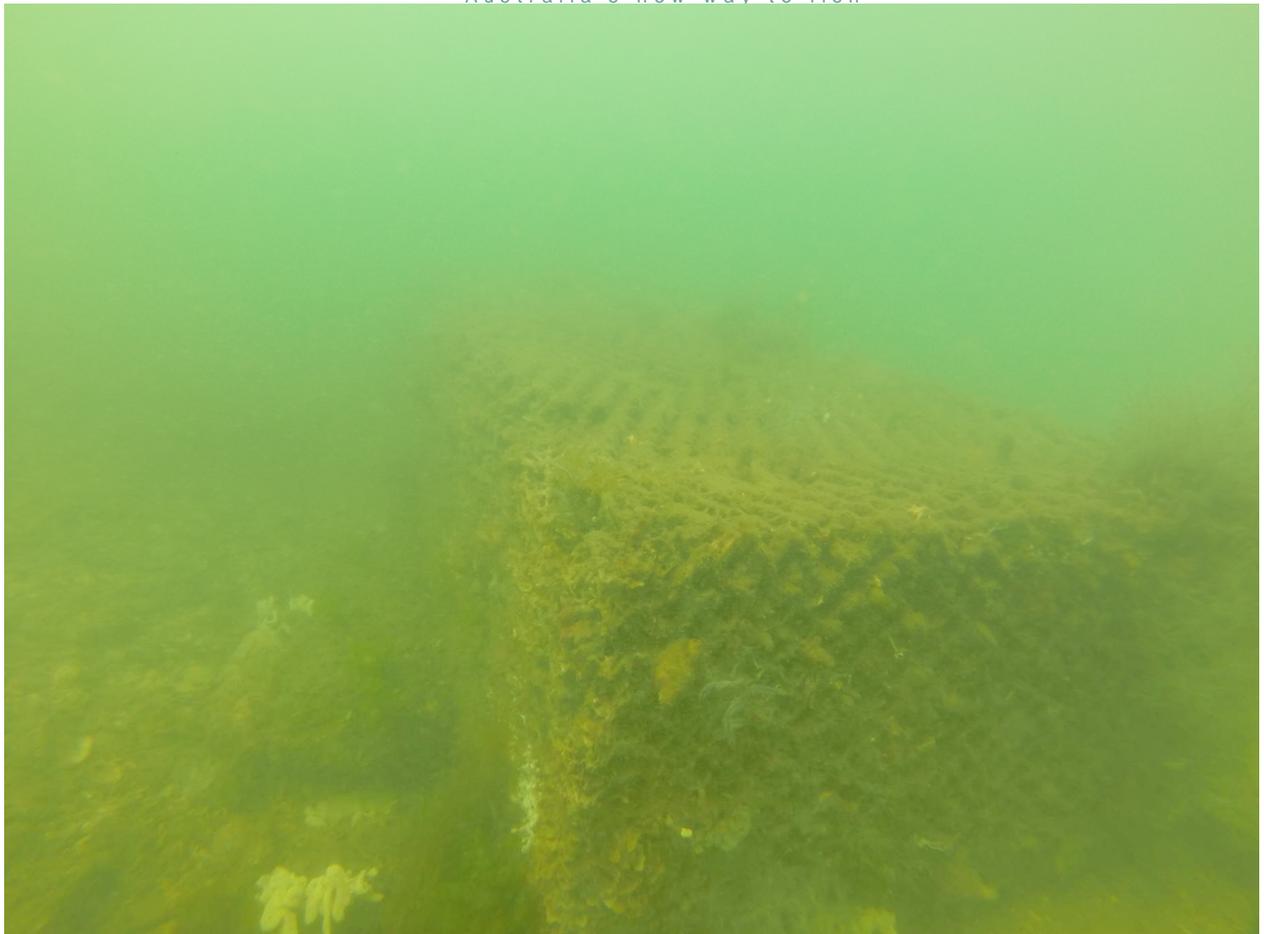
Reef Module #7 – BESE module with shell. Top of module showing macroalgal growth

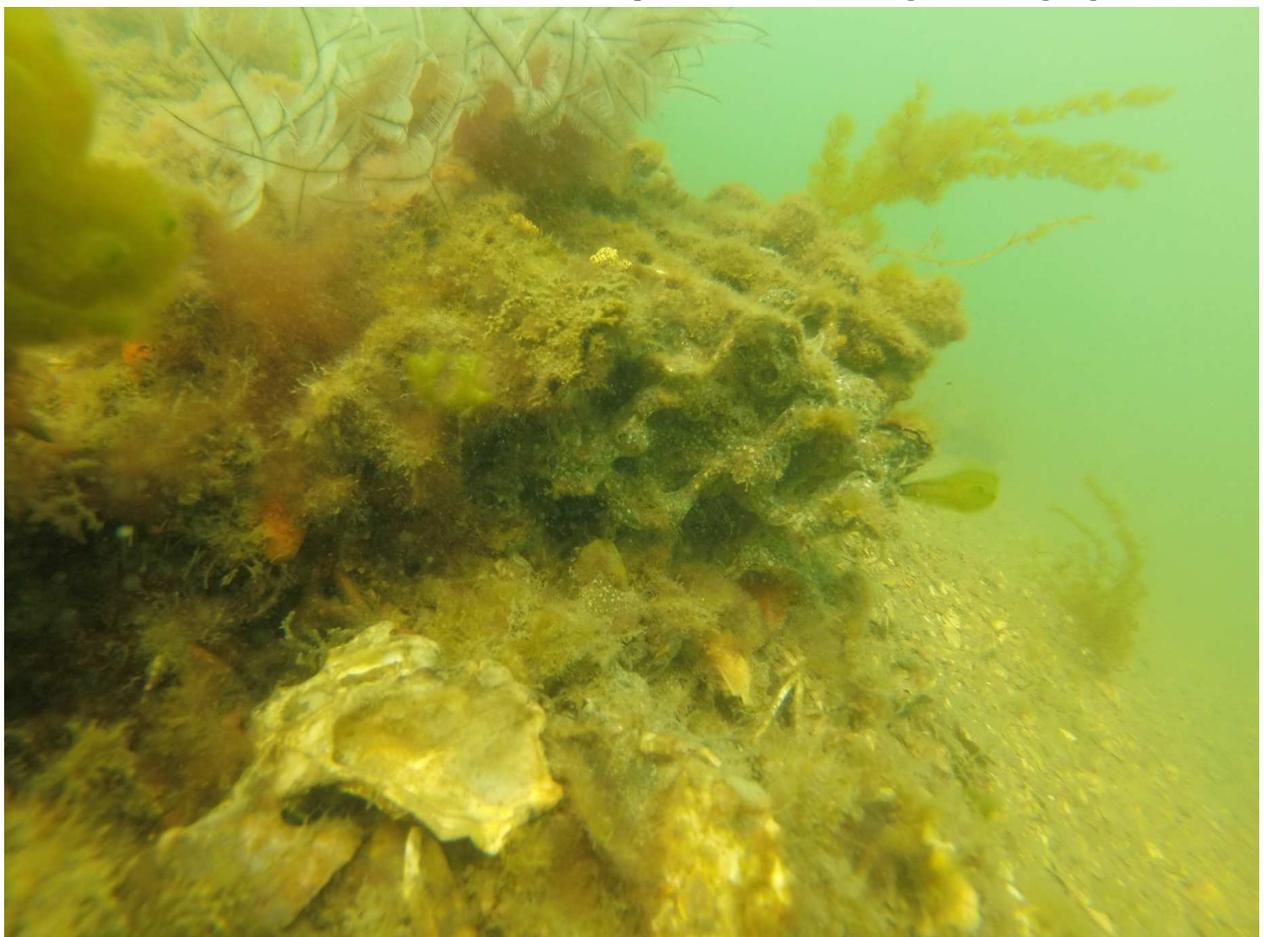
Reef Module #7 – BESE module with shell. Detail showing edge sedimentation and shells.

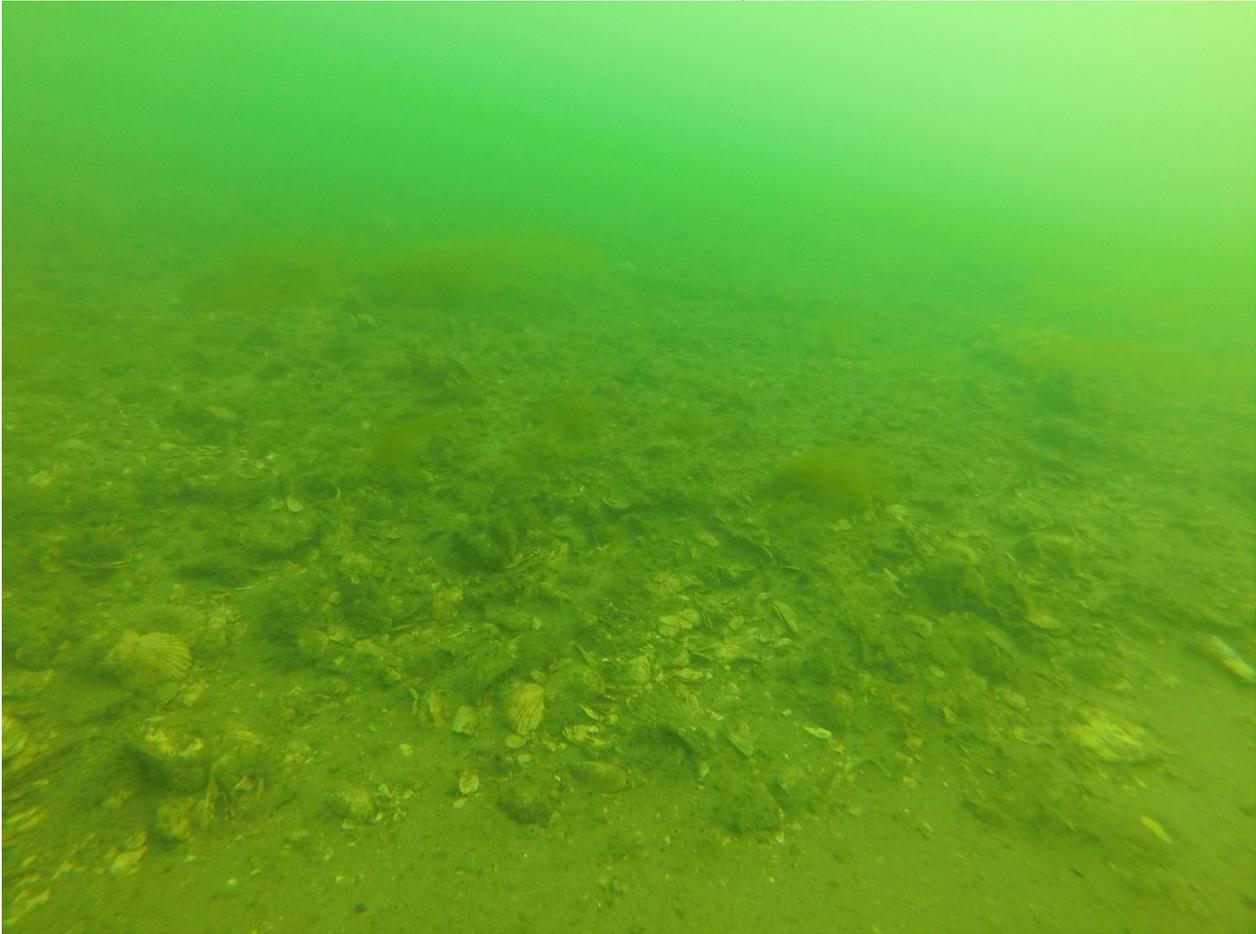
Reef Module #9 – Patch reef with dead shell. Note macroalgal overgrowth and loss of fence.

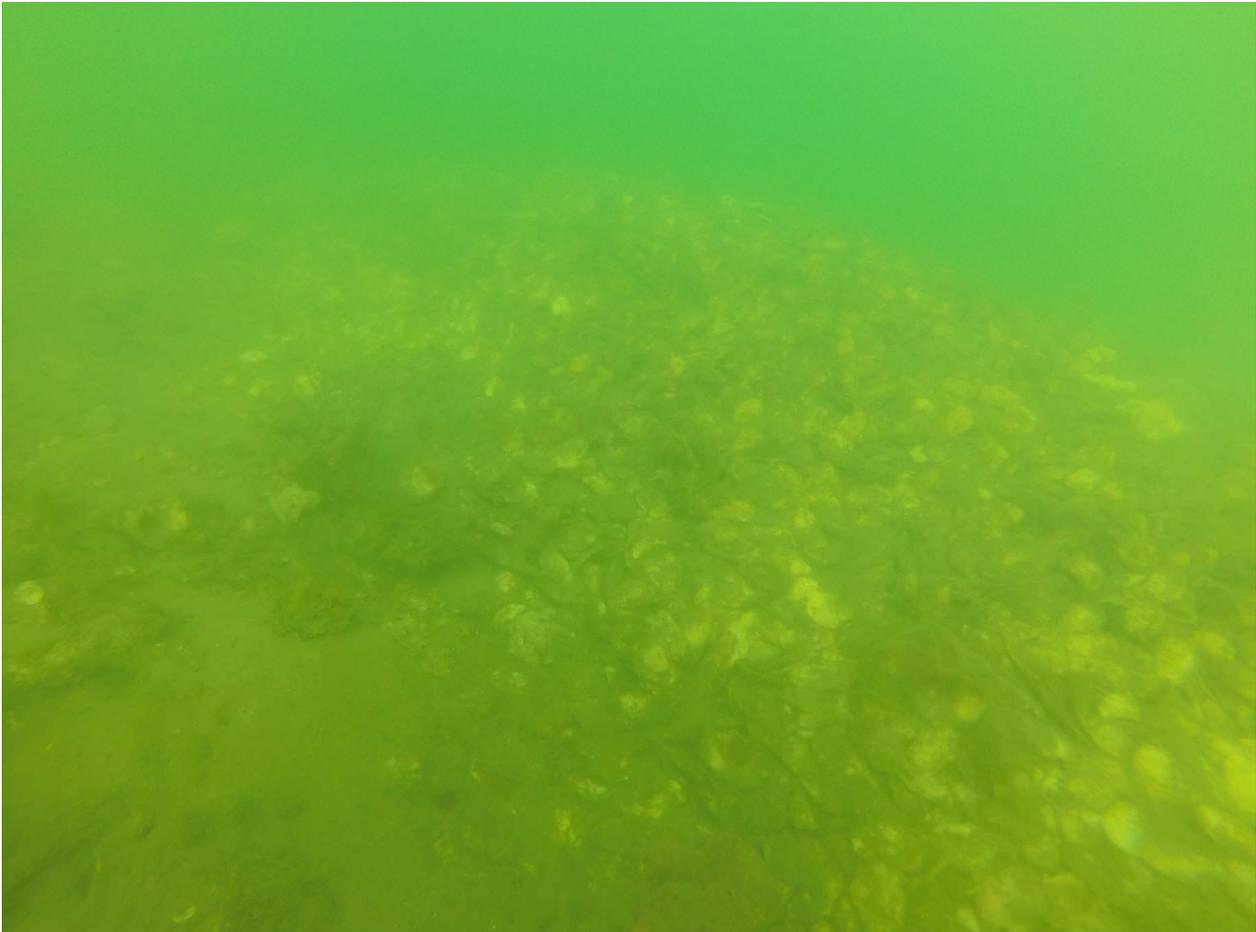
Reef Module #9 – Patch reef with dead shell. Note edge sedimentation to left of photo.
