# Pumicestone Passage Shellfish Reef Habitat Restoration Project – 9 Month Invertebrate Monitoring

**OzFish Unlimited**

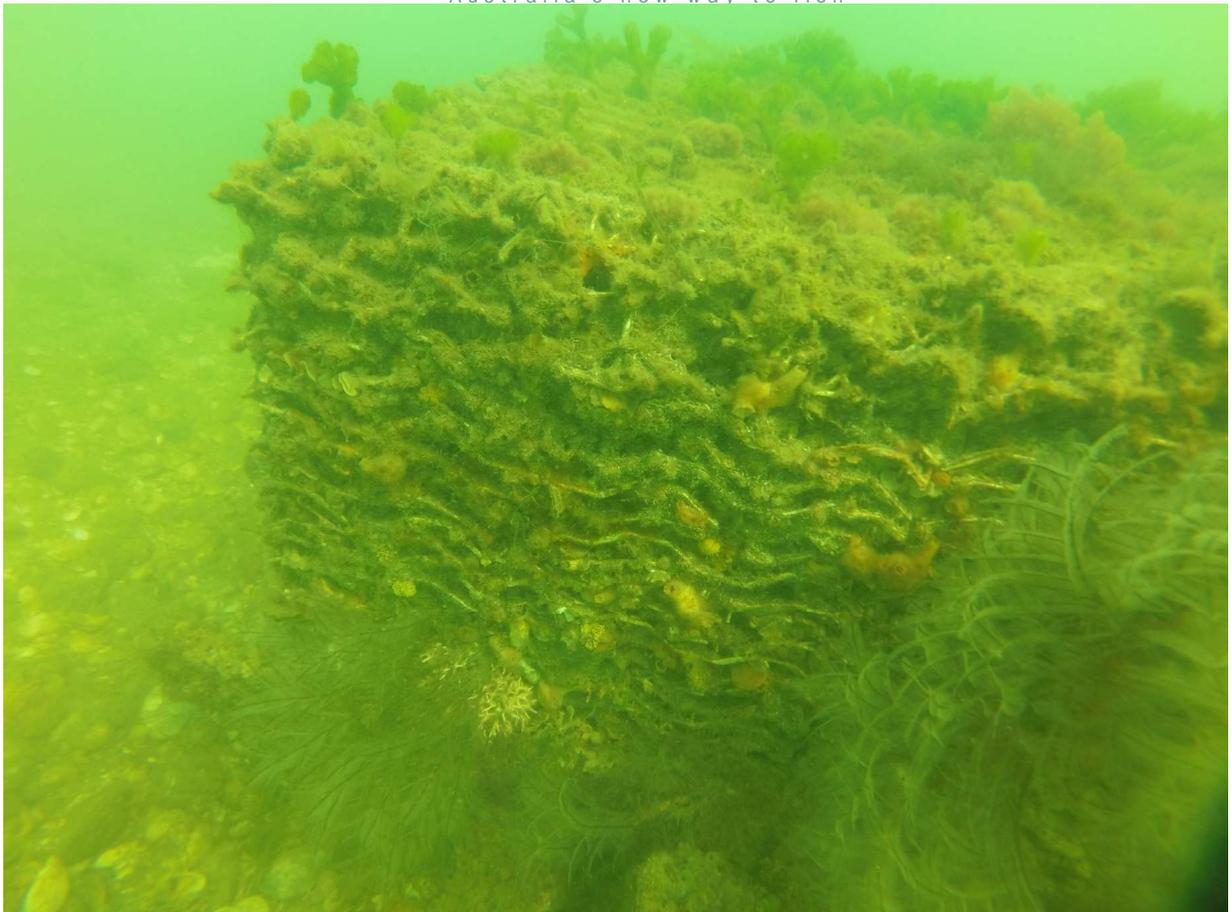
Reef Module #10 – BESE module with live oysters. Note reef growth along vertical sides.

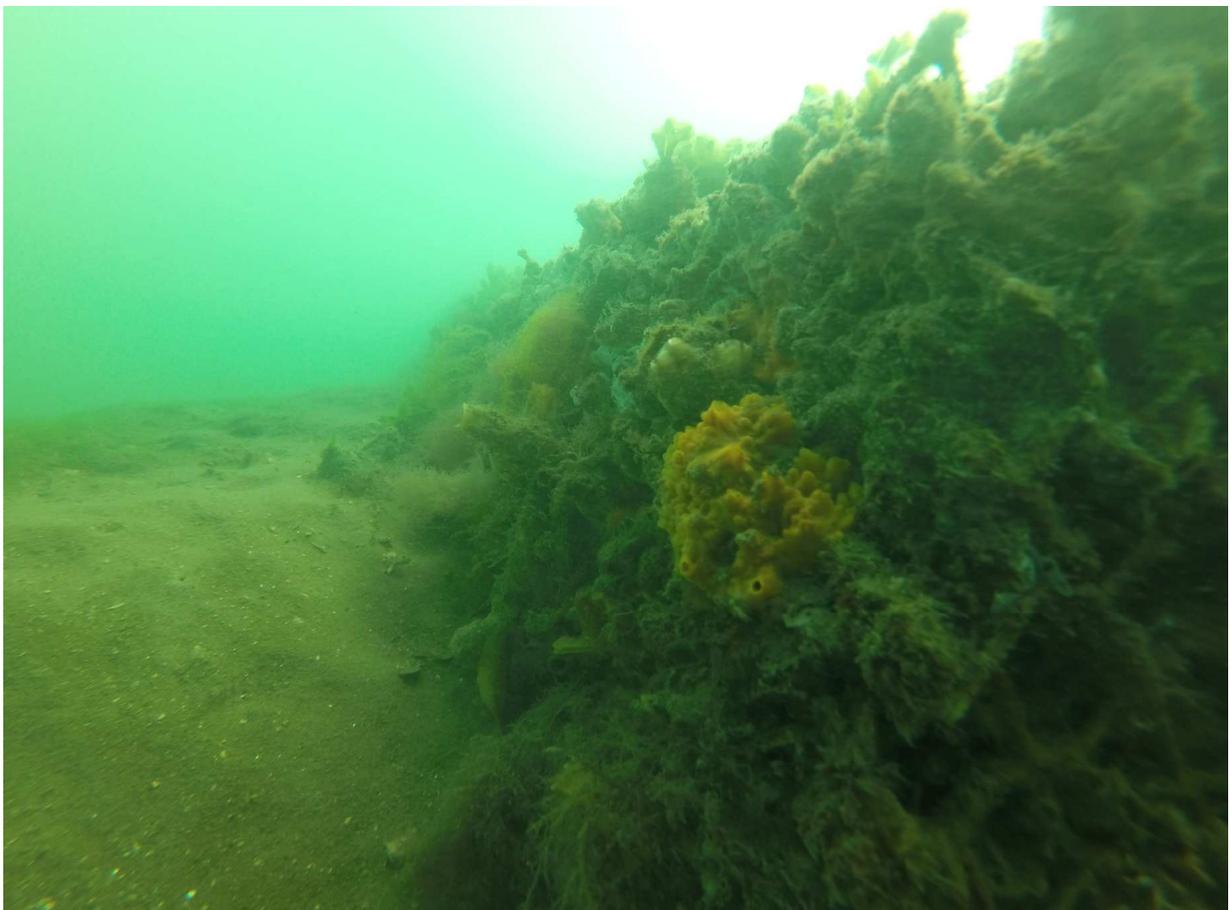
Reef Module #10 – BESE module with live oysters. Note edge sedimentation to left of photo.

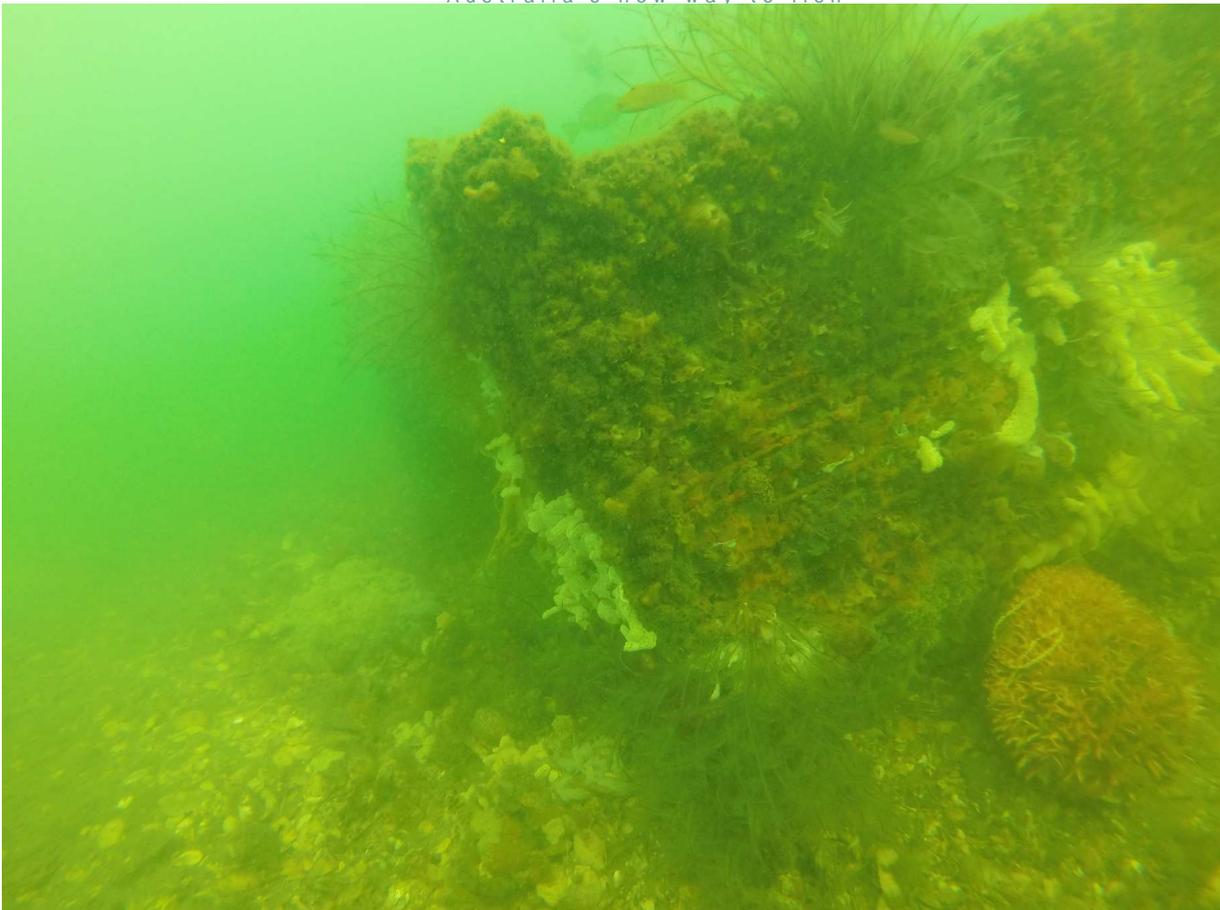
Reef Module #12 – Crate (wire cage) with live shell (uncovered). Note reef growth and fish.

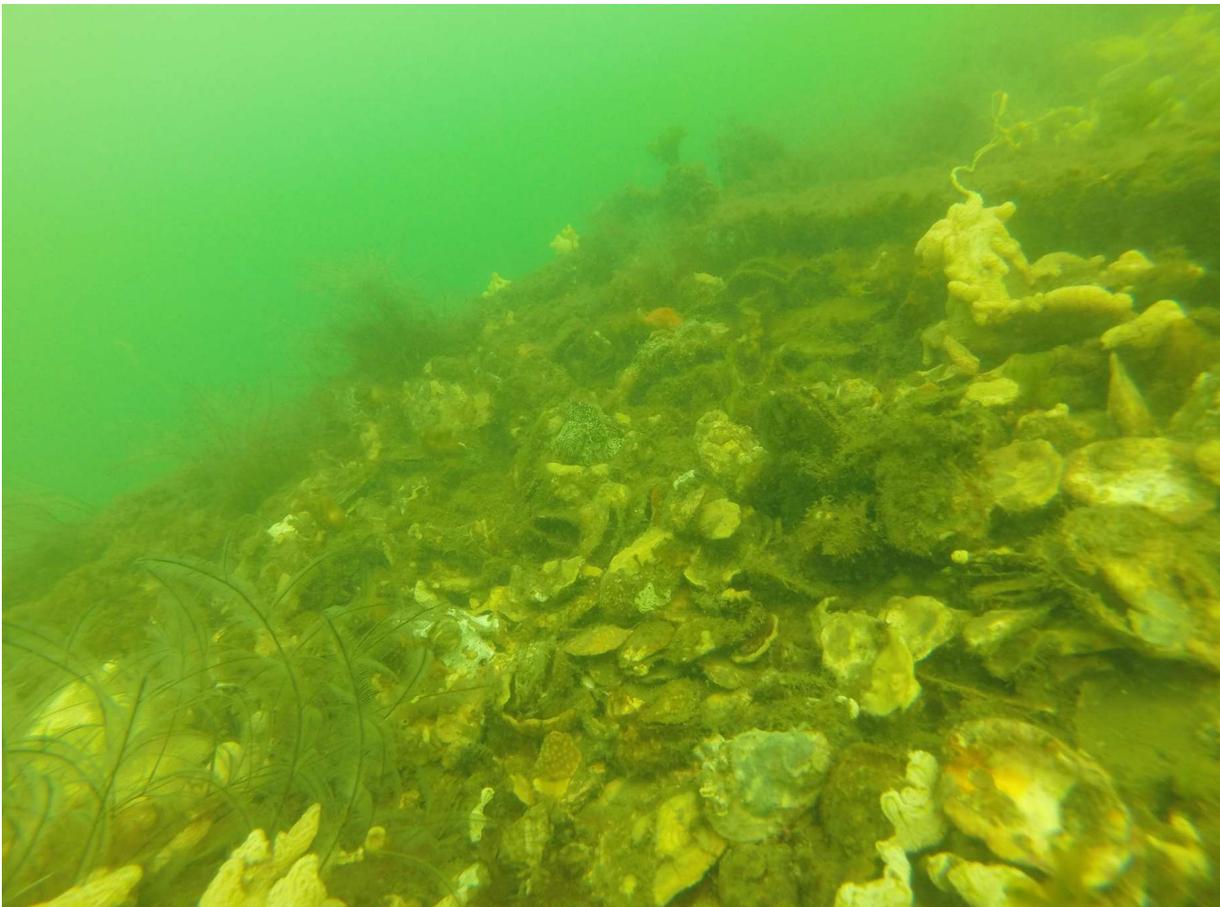
Reef Module #12 – Crate (wire cage) with live shell (uncovered). Note fish (absent as were scared away by the diver) have full access to the shell/live shellfish mix on top of cage.

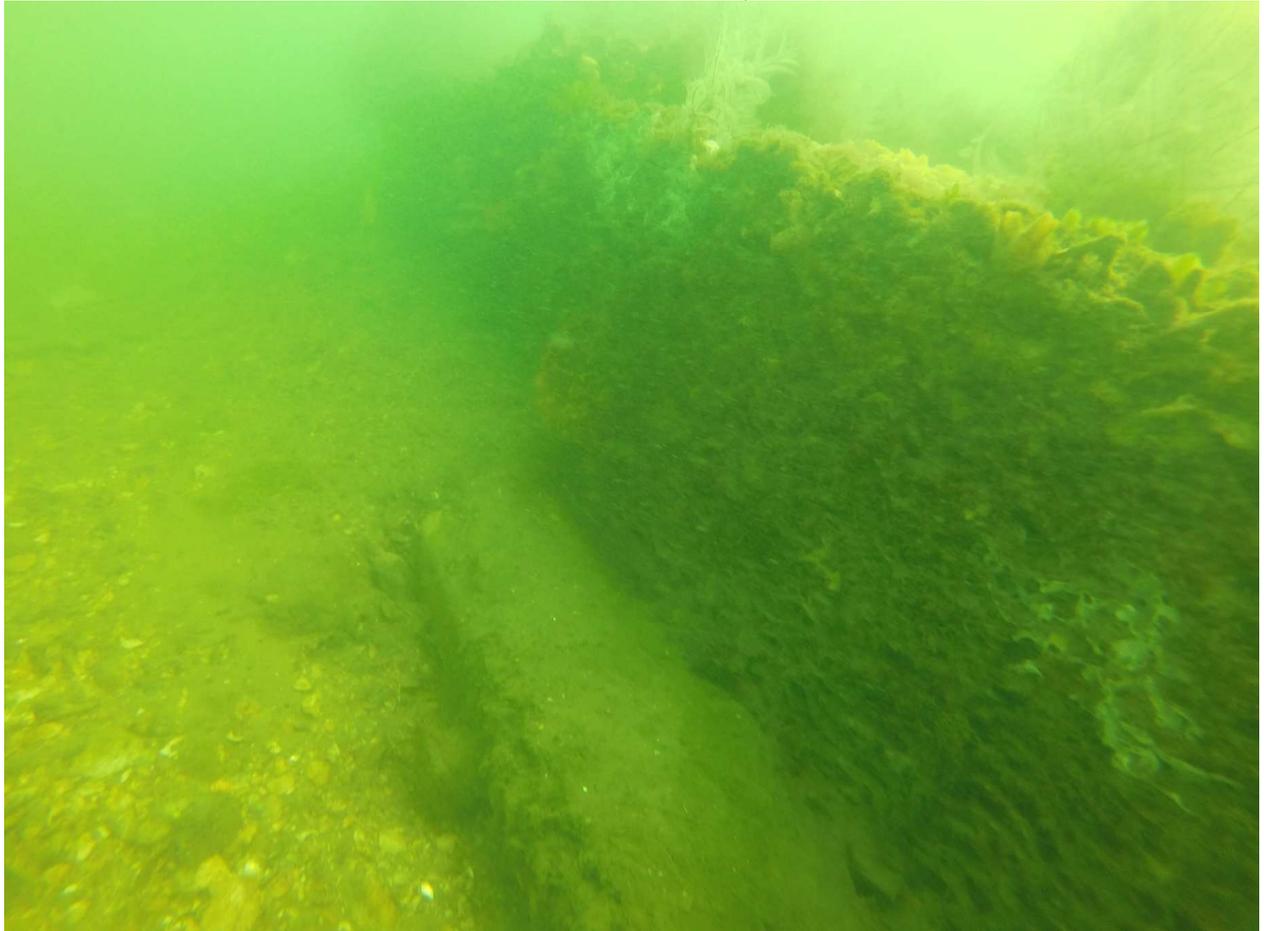
Reef Module #14 – BESE module. Note edge sedimentation to left and concrete mooring.

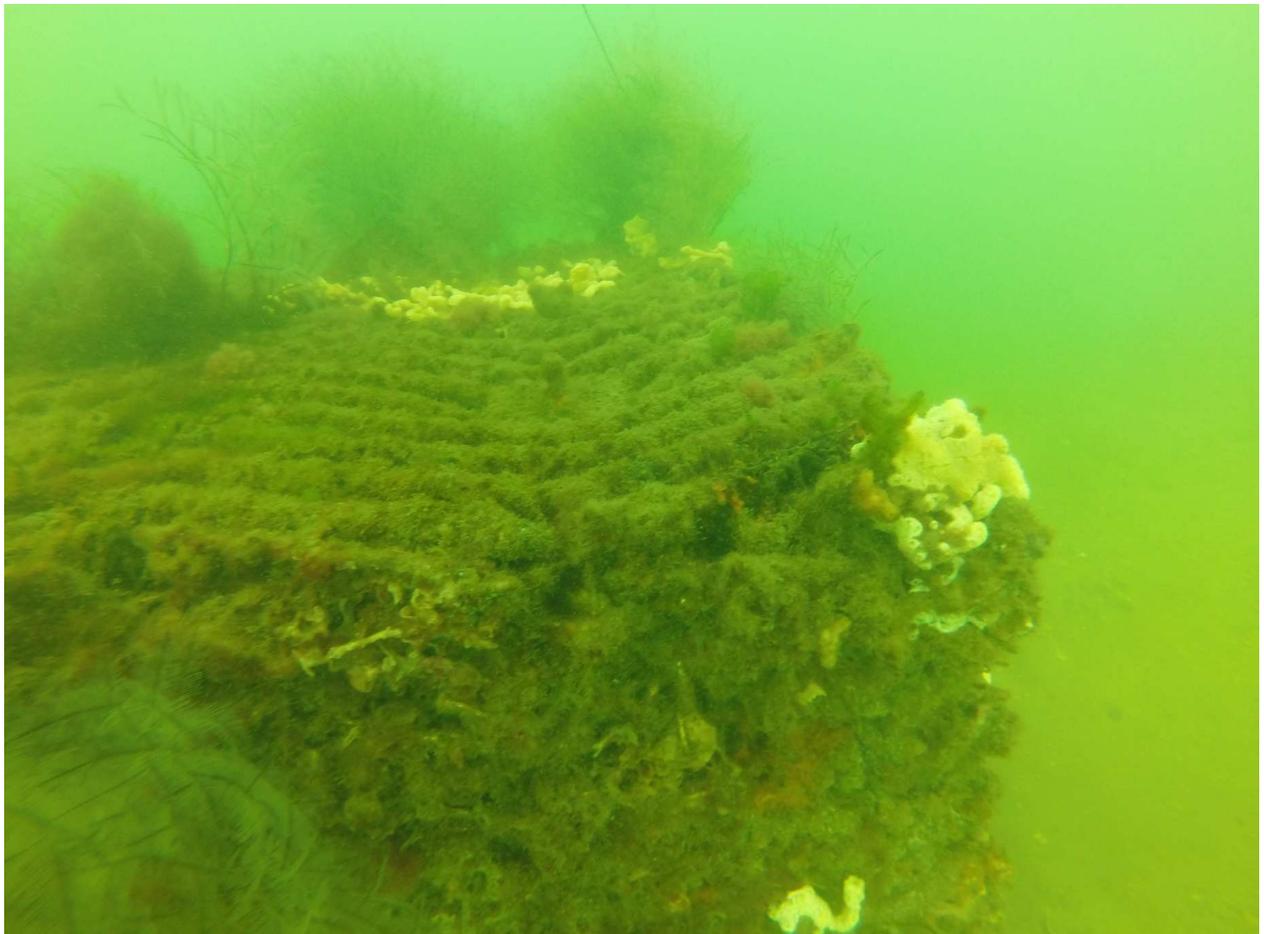
Reef Module #14 – BESE module. Note mix of macroalgal and reef growth.

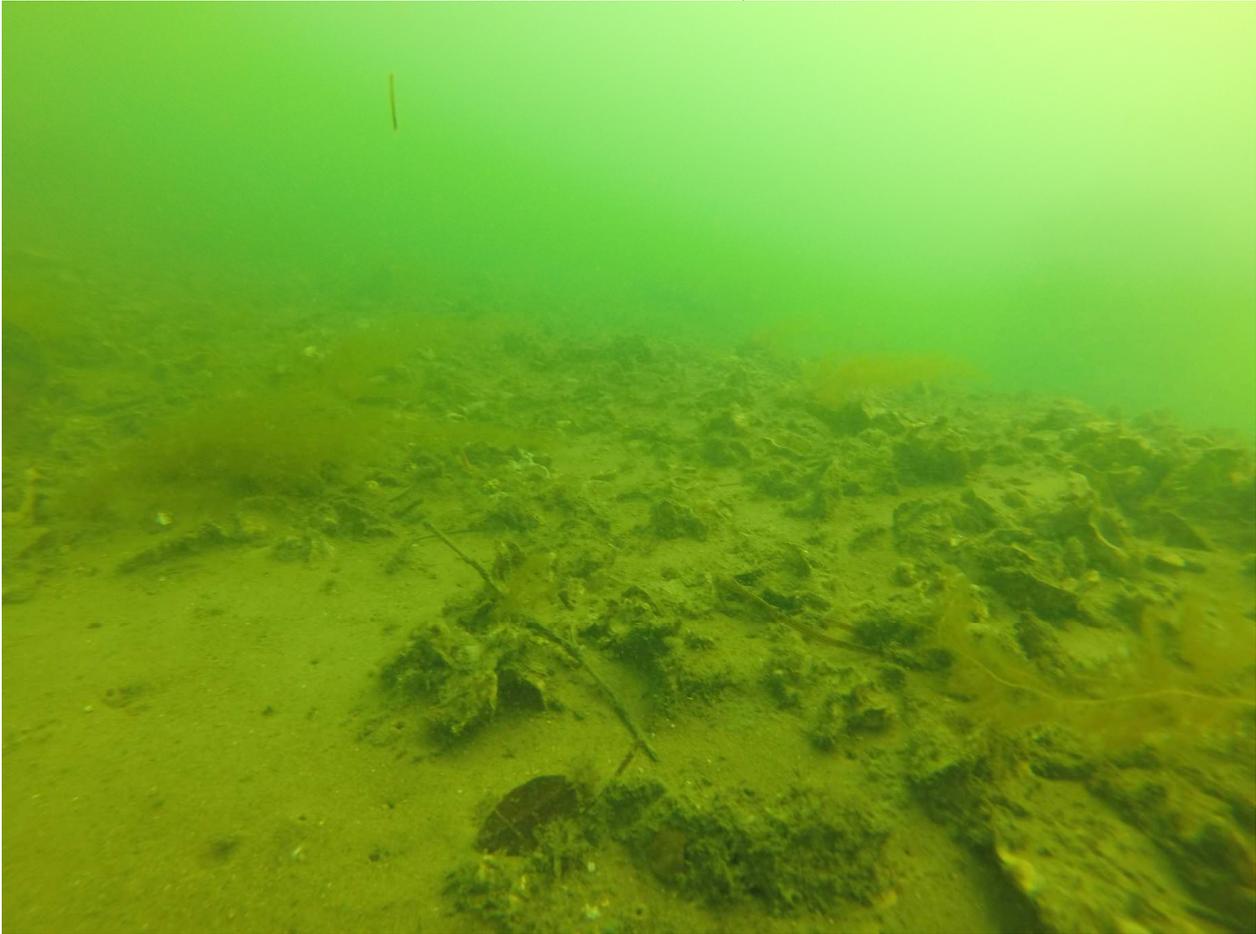
Reef Module #16 – Patch reef with live shell. Note sedimentation of edge (left) due to damage to besser block fence (see also Figure 10), and apparent lack of fish due to diver presence (compare to fish evident in video presented in Section 3.4).

Observations by divers together with underwater photographs (see Appendix 1) confirmed that anchor damage and sedimentation were both problematic, especially in patch reefs which used besser blocks as fence material. Anchor damage is likely to be greatly reduced if boating users in the immediate vicinity of the reefs could be warned by signage not to anchor in the restoration area. Sedimentation effects were evident along the edges of most of the reefs regardless of configuration. For the patch reefs, this "edge effect" problem could possibly be reduced by increasing the area and height of the shell piles (from c. 2 x 2 meters and 40-50 cm to at least 4 x 4 meters and 60-75 cm high) and using a more robust "fence" system around the patch reefs to retain shell and help reduce anchor damage.
