# Pumicestone Passage Shellfish Reef Habitat Restoration Project – December 2018 deployment 6 Month Invertebrate Monitoring

OzFish Unlimited, 20 June 2019

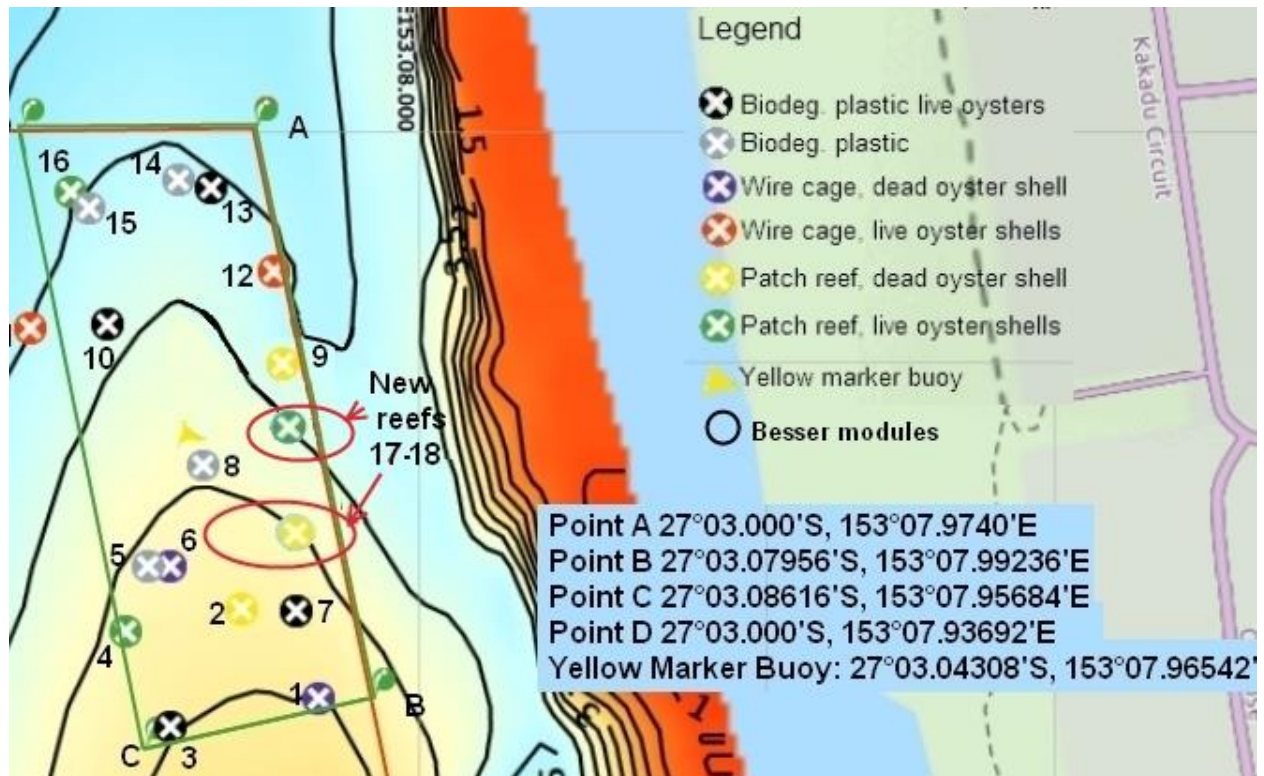
**Figure 2.** Detailed map of the project area showing bathymetry and layout of the new experimental reef modules #17 (north) and #18 (south) as well as location of crate reef #1. Description of reefs as per Table 1.

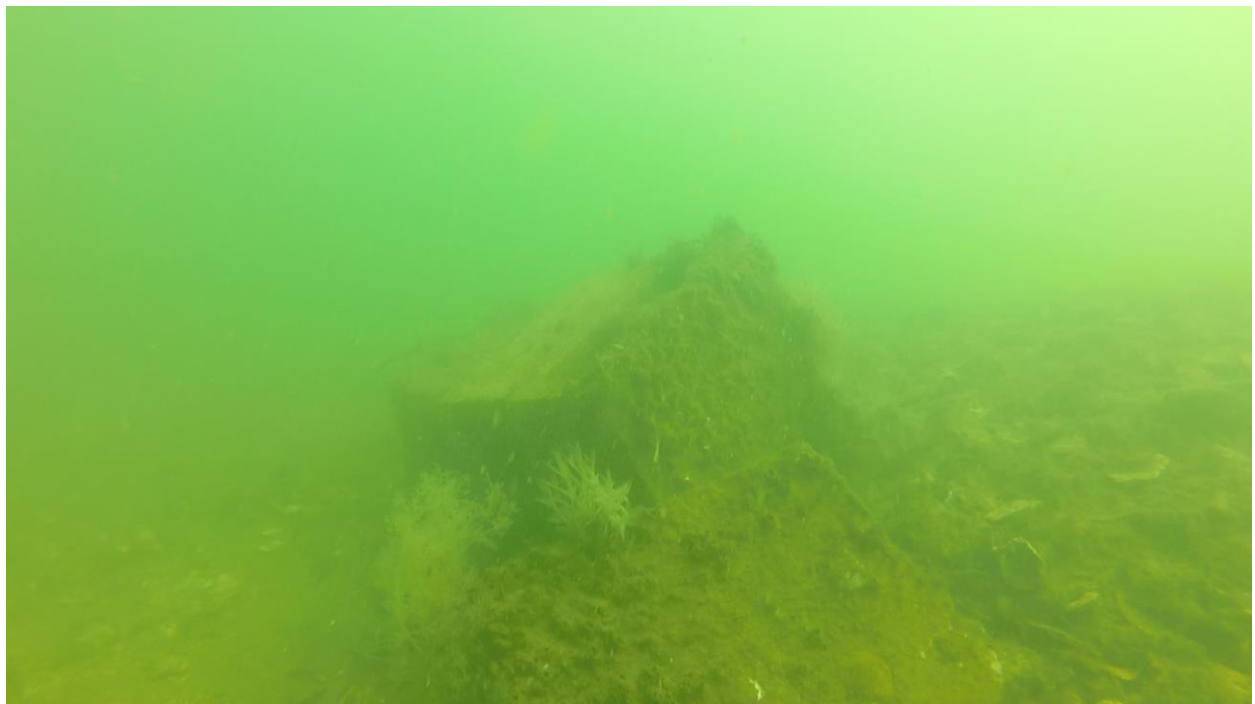
Diver inspection of the patch reefs found evidence of anchor damage on the fence modules surrounding the southern patch reef (Figure 4, underwater video available at [https://youtu.be/om8NH7\\_8lO4](https://youtu.be/om8NH7_8lO4)). Parts of the northern patch reef that were covered by geofabric mesh remained covered in sand and silt, however in contrast, the uncovered section remained in good condition (Figures 5, 6, underwater video available at <https://youtu.be/G5CY2apoZYQ>). The geofabric was disintegrating in some areas where it was partially removed. A summary of the underwater videos documenting the condition of these reefs obtained by divers during invertebrate sampling trips is contained in Table 4.

**Figure 4.** Anchor damage was evident on the besser block fence of the southern reef (#18). Given the increased size and weight of the fence modules used for the December 2018 deployments, this damage must have been done by a large boat powering a stuck anchor off the reef after ignoring signage and advice not to anchor in the area.

It is hypothesised that the revised design of the taller, more robust fence modules and the larger size of the experimental reefs in the December 2018 deployment have, reduced (but not eliminated) the detrimental effects of anchor damage, such that we have managed to replicate the spat recruitment performance observed on the crate reefs, but it still appears that spat survival remains slightly higher on the crate reefs. This may be a function of reduced predation of oyster spat on shells in crate reefs. Video observations have found

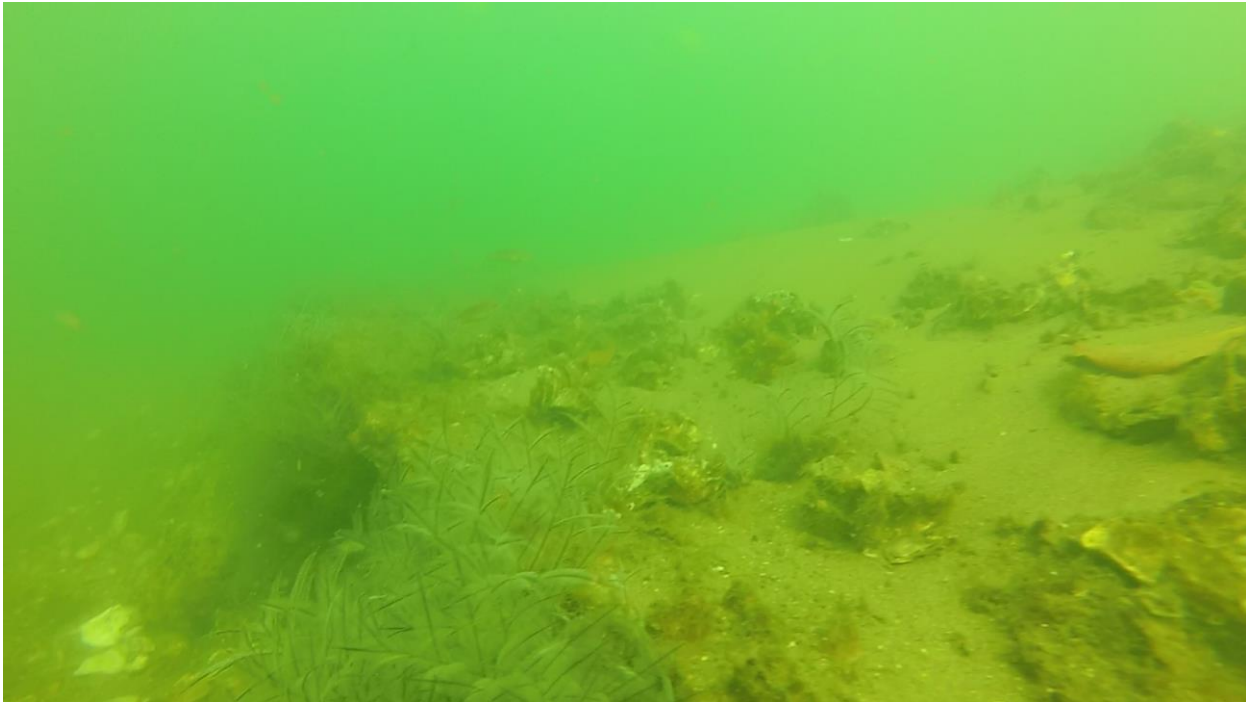
**Figure 5.** Sedimentation of the side of the northern reef (#17) covered with a geofabric cover as required under Fisheries permit. This excessive sedimentation due to the cover is obviously extremely detrimental to the shellfish reef.

Of course, these epibionts also combine with natural oyster shell processes to help cement the loose shells together (Burkett et al. 2010) into a monolithic reef formation (Diggles et al. 2018). Indeed, we now have 1.5 years of empirical evidence from oyster reef trials in Pumicestone Passage that demonstrates that live oysters deployed over the top of experimental shell reefs in both 2017 and 2018 remained exactly where we put them, bound together by natural processes. This natural reef consolidation process negates any need to cover these reefs with coir netting or other mesh to “adequately contain” live shells that may be used to enhance the reefs. Indeed, after 6 months observations of reef #17 and comparisons between it and reef #18, we can confirm beyond doubt that covering shellfish reefs with artificial netting also promotes sedimentation that will smother the covered area of the reef. Thus, coir netting is not required or desirable for future reef restoration efforts.

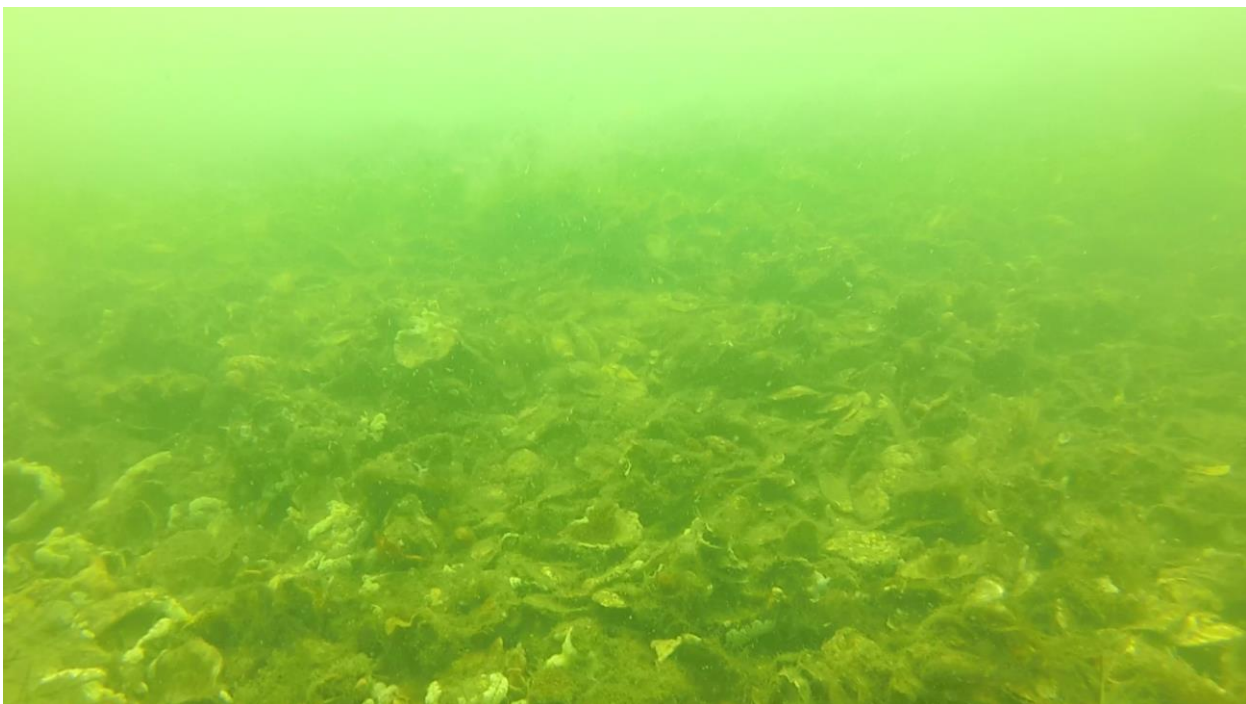
**Figure 6.** In contrast to Figure 5, the uncovered side of the northern reef (#17) appeared in excellent condition, demonstrating that oyster shells interlock and are quickly cemented together by invertebrate fouling organisms, making any need to cover them redundant.

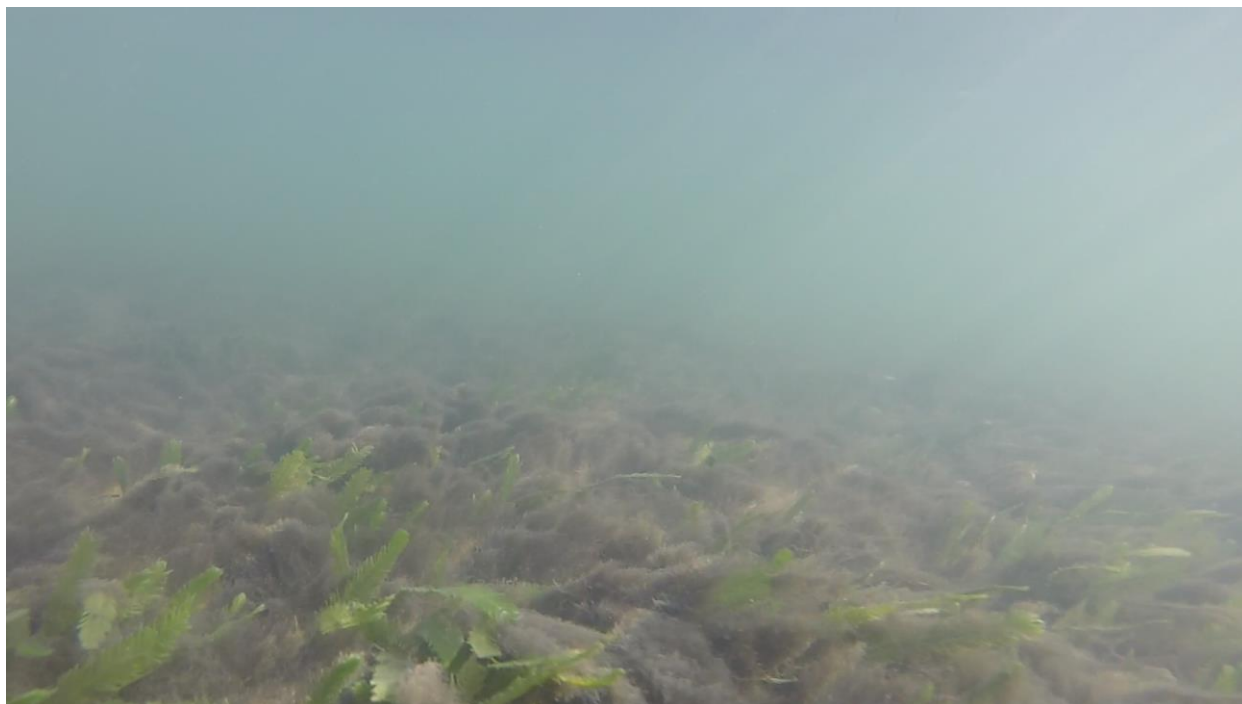
Early in the morning of 10 June 2019 prior to sampling of the experimental shellfish reefs it was noticed that seagrass beds near the Avon wreck were being smothered and choked by a bloom of *Ectocarpus* spp. (snotweed) (Figure 7). Blooms of snotweed have been recorded at this time of year in previous studies (e.g. Diggles 2017) and they now seem to be an annual event that coincides with increased water clarity during the winter months. The clear water allows sunlight penetration to the bottom where the eutrophic conditions of the Pumicestone Passage stimulates abundant algal growth, which reduces the functional surface area, fisheries productivity and ultimately the survival of these seagrass meadows (which themselves require sunlight for growth).

**Figure 7.** At the time of sampling, the seagrass beds near the Avon wreck were being smothered by a bloom of *Ectocarpus* spp. (snotweed). These brown algae blooms are now annual events that coincide with increased water clarity during the winter months, providing more evidence of the degraded, eutrophic condition of Pumicestone Passage.

An incidental finding on the morning of sampling was the fact that nearby seagrass meadows just south and west of the Avon wreck were being smothered by profuse brown algae (*Ectocarpus* spp.) blooms. Blooms of snotweed now seem to be an annual event in Pumicestone Passage (Diggles 2017) and their emergence coincides with increased water clarity during the winter months. The clear water allows sunlight penetration to the bottom where the eutrophic conditions of the Pumicestone Passage stimulates abundant algal growth, which smothers the seagrass strands reducing its functional surface area and thus its suitability as fish habitat. These algal blooms are thus a significant threat to fisheries productivity and ultimately the survival of these seagrass meadows, given that the shading of the algae reduced sunlight availability needed for seagrass growth. It is notable that shellfish reef restoration can benefit seagrass conservation and recovery through increased filtration of seawater (improving water clarity and light penetration), as well as through increased nutrient uptake (Newell et al. 2004).
