Pumicestone Passage Shellfish Reef Habitat Restoration Project – December 2018 deployment 9 Month Invertebrate Monitoring

**Dr Ben Diggles, Robbie Porter, Jaedon Vardon, Cameron MacFarlane, and Elle Veary
OzFish Unlimited, 18 September 2019**

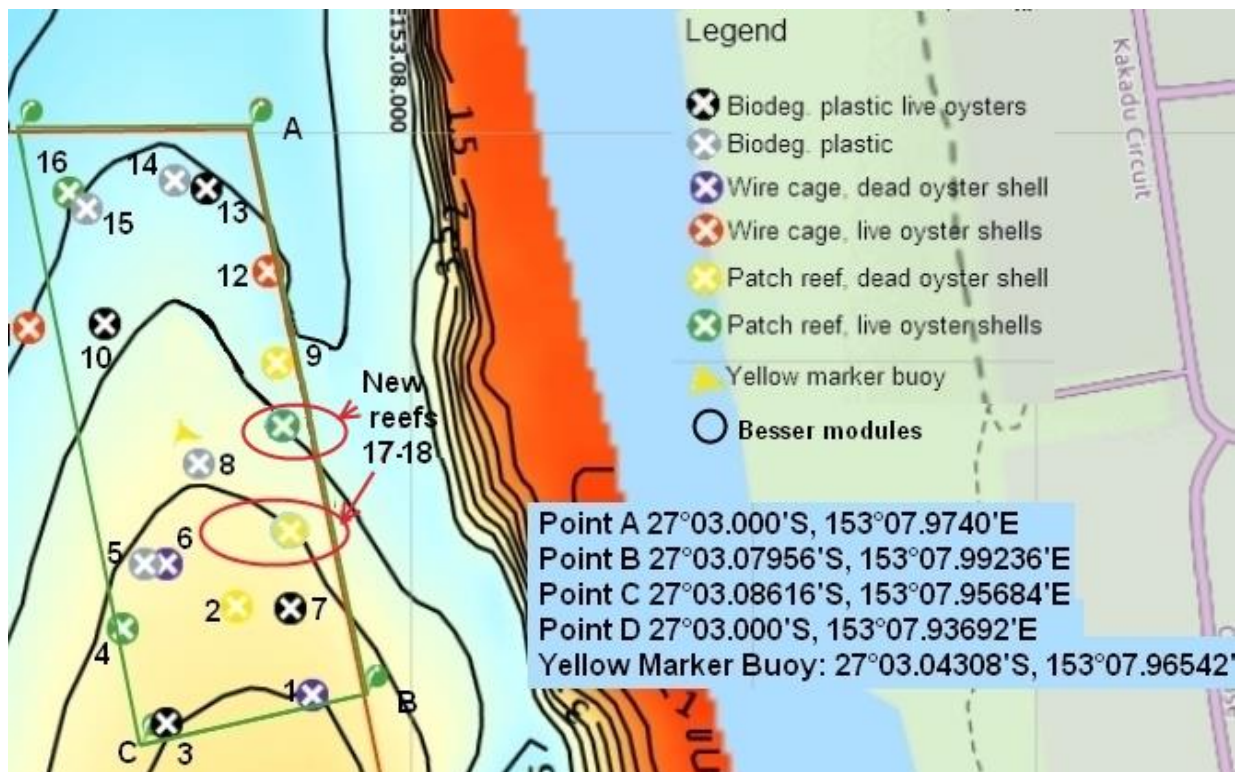
Figure 2. Detailed map of the project area showing bathymetry and layout of the new experimental reef modules #17 (north) and #18 (south) as well as location of crate reef #1 and patch reef #16. Description of reefs as per Table 1.

December 2018 (Figures 1, 2). The southern patch reef (constructed with c. 20 m³ of dead oyster shells surrounded by 55 besser block fence modules), was located around 30 meters south east of the marker buoy, while the northern patch reef (a mix of 1.5 m³ of live and c. 14 m³ of dead oyster shells covered with a geofabric cover surrounded by 45 besser block fence modules) was located around 20 meters north east of the marker buoy (Table 1, Figure 2). Each of the reef modules was first located and marked with a marker buoy before the divers inspected them and obtained samples of shells by hand which were placed in a fine mesh (3 mm) dive bag and taken to the surface.

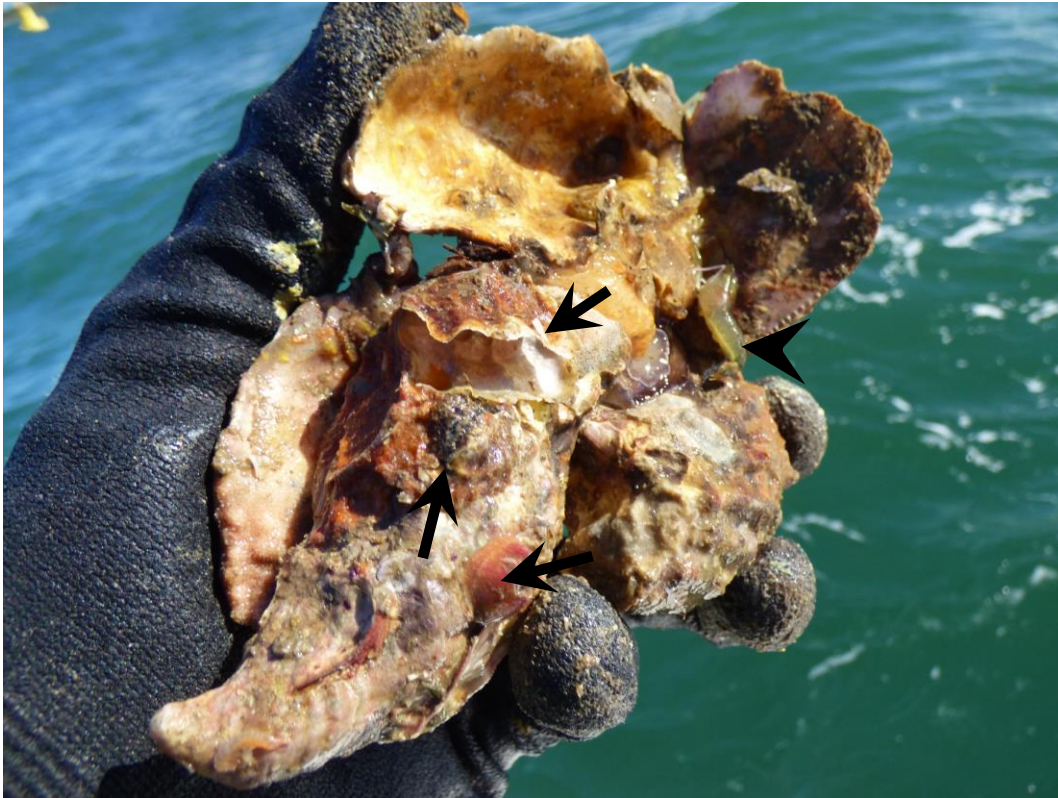
Figure 3. Photo of typical invertebrate recruitment cementing oyster shells together after 9 months on the southern reef (#18). Multiple oyster spat (arrows), various encrusting corraline algae, colonial tunicates and a snapping shrimp (arrowhead) are evident.

Data from these samples found the northern patch reef (#17) had 66 spat per 100 shells (Table 2), which was within the range of previous samples taken from that reef 3 months earlier (60-83, mean 71.5 spat per 100 shells, see Table 3). In contrast, the number of spat counted from the sample from the southern patch reef (#18) was slightly higher (86 spat per 100 shells, see Table 2), than previous samples (range 62-66, mean 64 spat/100 shells) taken from this reef 3 months ago (Table 3). Based on visual identification of spat sampled, there was no evidence of additional rock oyster (*Saccostrea* spp.) spatfall over winter. However, there was evidence of a small amount of recent honeycomb oyster (*Hyotissa* spp.) spatfall, particularly on the southern patch reef (#18), since the previous quarterly sample in June. Sampled shells all had significant invertebrate recruitment evident (Figures 3, 4)

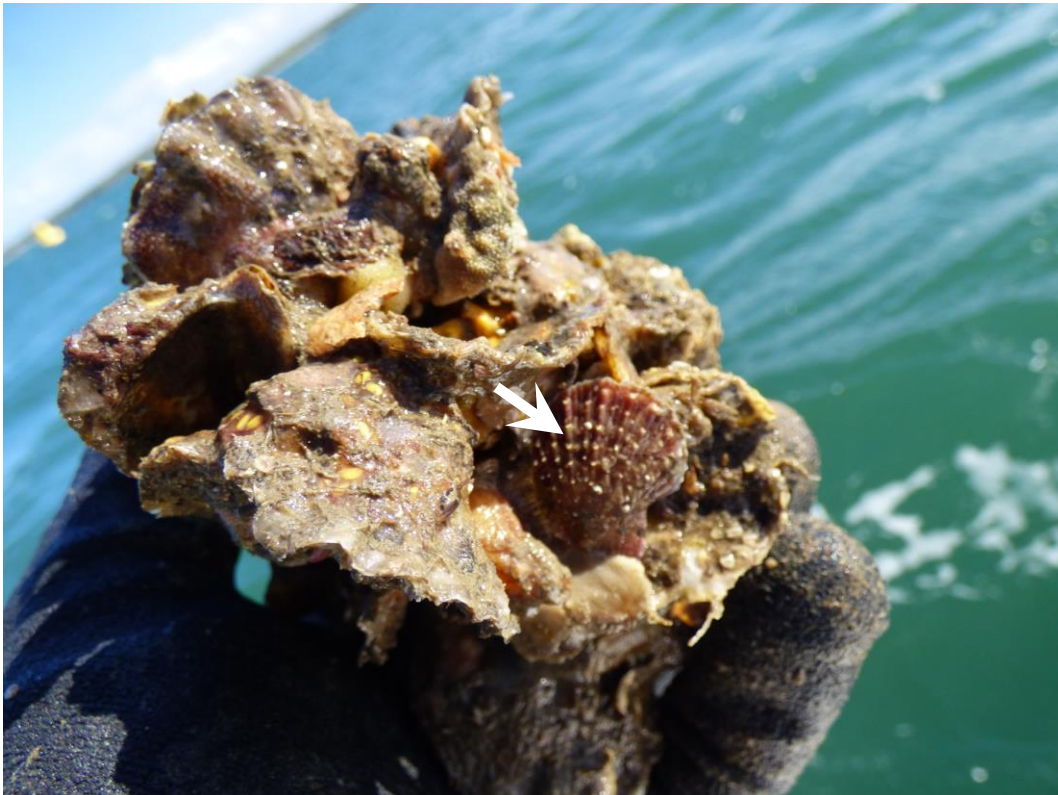
Figure 4. A clump of oyster shells sampled from the northern reef (#17), showing them cemented together by corraline algae and colonial tunicates. A recruited glory scallop is also evident (arrow).

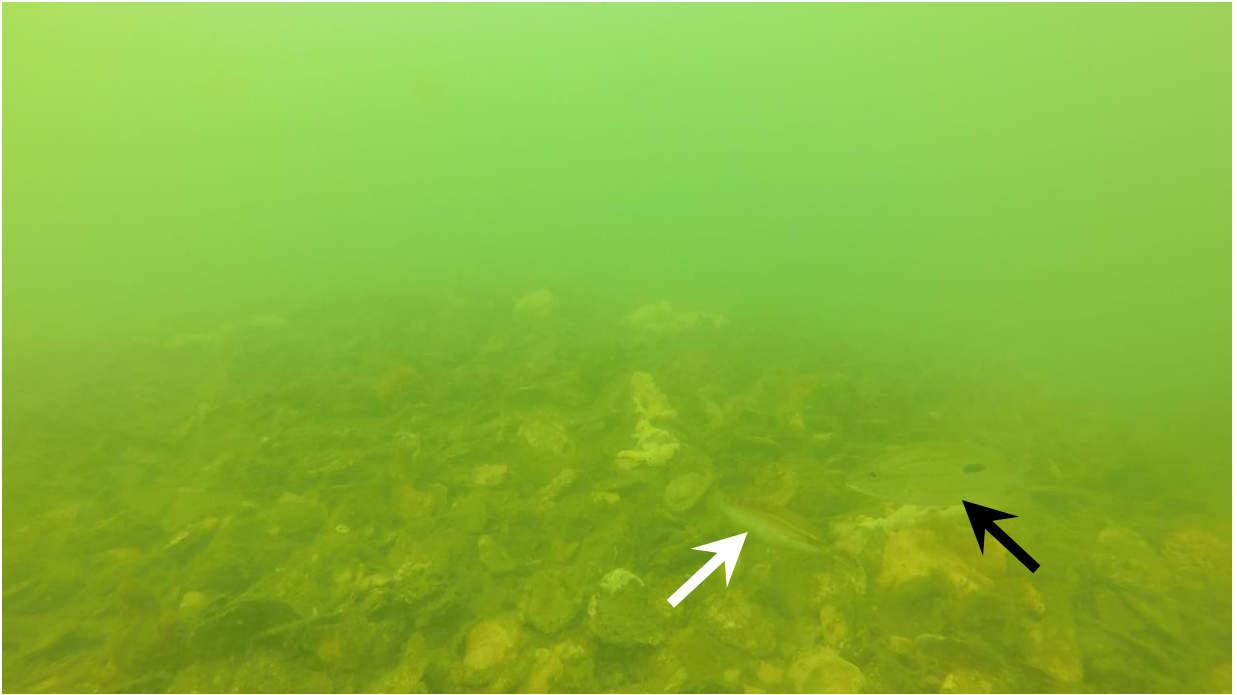
Figure 5. Photo taken from a video of the southern reef (#18), showing poor visibility due to resuspended sediment and benthic algae (snotweed) in the water. A Gunther's wrasse (white arrow) and Moses perch (black arrow) are evident in the foreground.

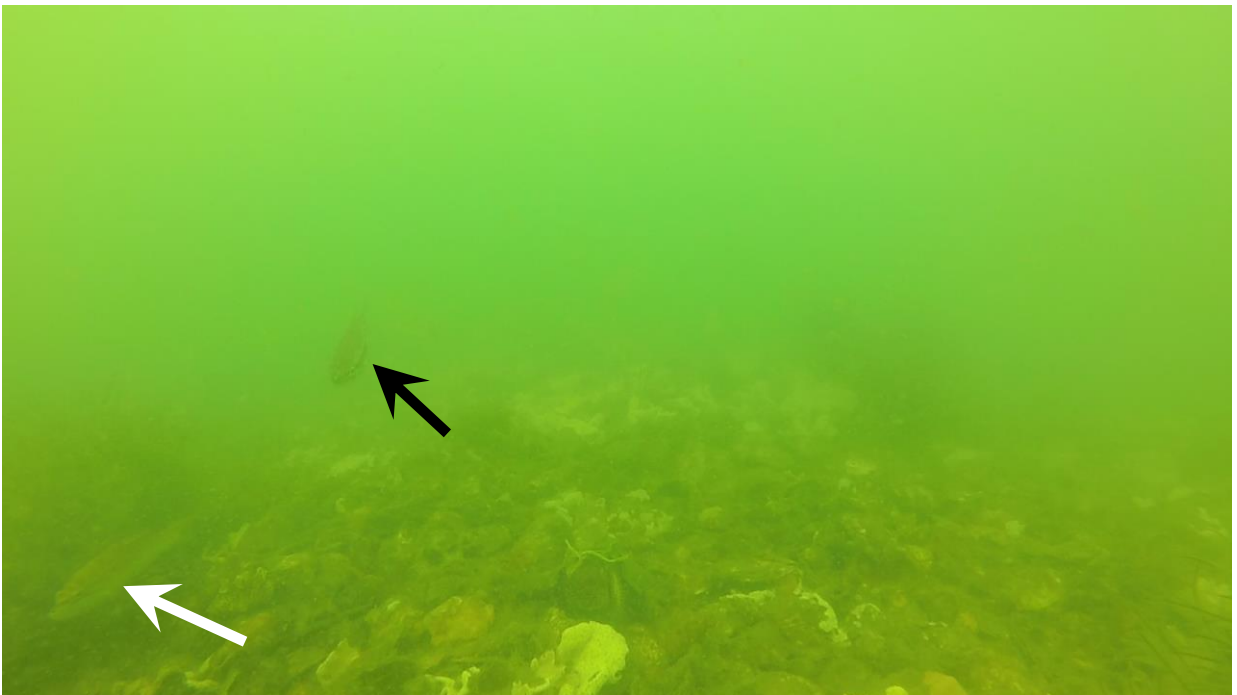
Figure 6. Photo taken from a video of the northern reef (#17), showing poor visibility due to resuspended sediment and benthic algae (snotweed) in the water. A Gunther's wrasse (white arrow) and whiptail (black arrow) are evident in the foreground.

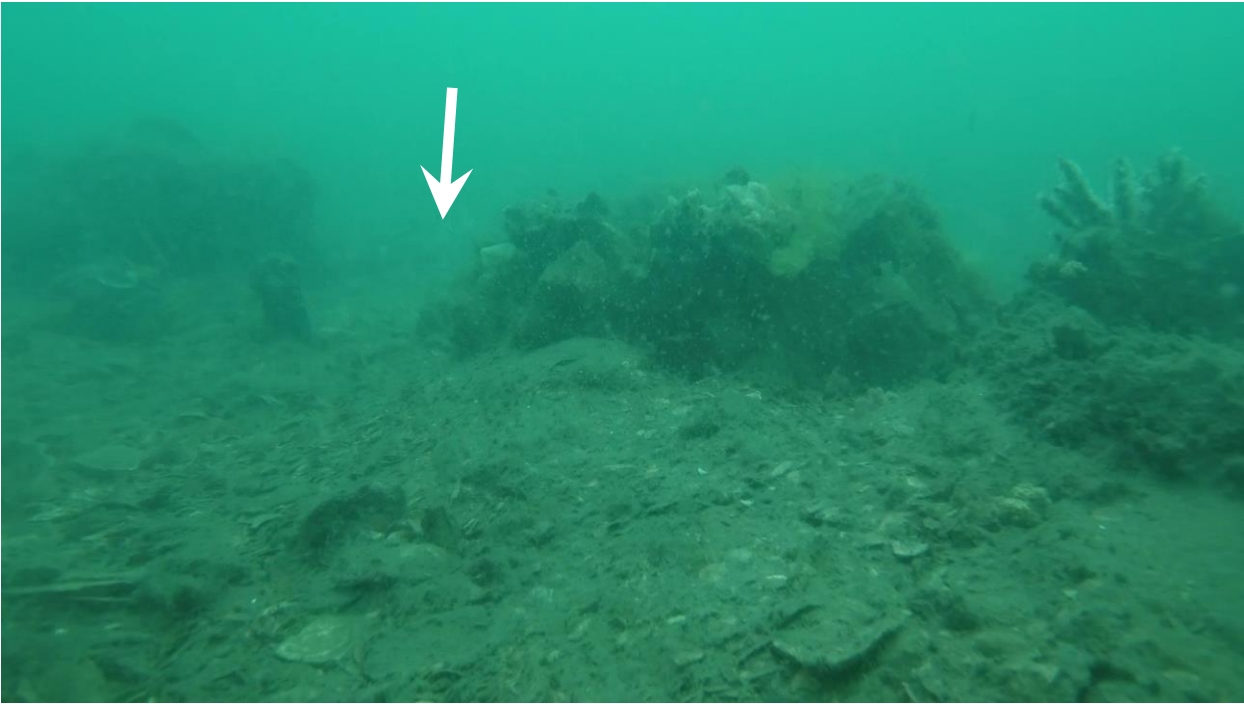
Figure 7. Photo taken from an underwater drone video showing poor condition of a patch reef deployed in 2017 which has had numerous besser fence blocks removed (arrow) and the shell knocked flat by anchor damage.

During this sampling period and in previous months the authors have witnessed first hand several boats attempting to anchor directly onto the experimental reefs. The revised design of the taller, more robust better block fence modules deployed in December 2018 have, reduced, but apparently not eliminated, the detrimental effects of anchor damage. Given the heavy fishing effort that is being expended over the restoration site (BK Diggles, personal observations), and the lack of appropriate signage advising boaters not to anchor in the area, it is likely that dozens of anchoring events are occurring over these experimental reefs every week. Anchor damage, rather than lack of recruitment of oysters, is therefore likely to be the major threat to the longevity of restored subtidal shellfish reefs in Pumicestone Passage. Given that signage at boat ramps and educational/awareness campaigns in the local media and community groups have not worked to reduce or eliminate anchoring damage during this trial, the high threat from anchor damage may be reduced by:

- proper signage on the marker buoy advising boaters not to anchor nearby; and/or
- addition of 4 smaller marker buoys at the 4 corners of the area to help boaters to line up the edges of the restoration area so they can avoid it; and/or
- provision of permanent anchor buoys which boaters can tie onto in lieu of using anchors that will damage the reefs.
