# **Pumicestone Passage Shellfish Reef Habitat Restoration Project – December 2018 deployment**

## **12 Month Invertebrate Monitoring**

**OzFish Unlimited, 31 December 2019**

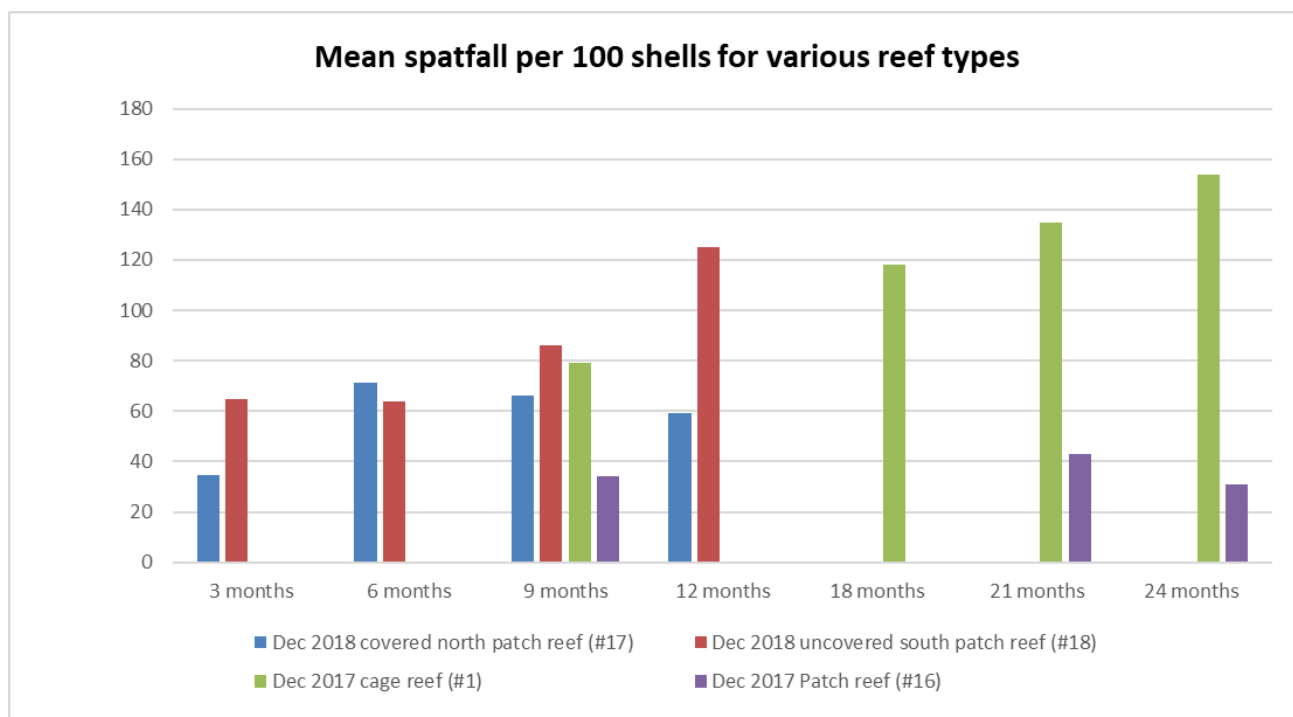
**Figure 3.** Graphical representation of changes in spatfall numbers over 12 months (patch reefs #19 and #20, December 2018 deployment) and 24 months (cage reef #1 and patch reef #16 deployed in December 2017) for trial reefs deployed in Pumicestone Passage. The data for reefs #1 and #18 suggest that recruitment is likely to be ongoing year-on-year when oyster shells are not covered by geofabric mesh and maintained at least 50 cm above the surrounding substrate.

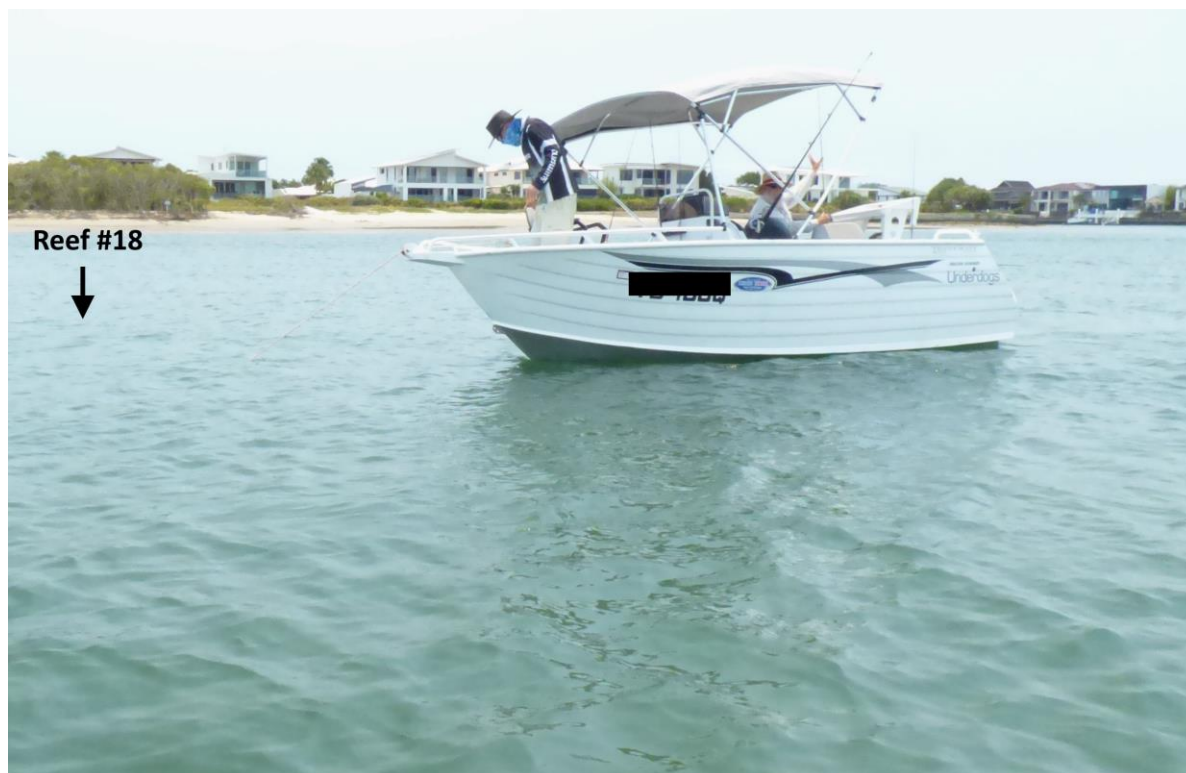
**Figure 4.** Photo of a recreational vessel that was found anchored on reef #18 around the low tide on 22 December 2019. The crew stated their anchor dragged slightly until it took hold, and they were unaware of the restoration project due to lack of signage.

A recreational vessel was found anchored on the southern patch reef #18 (Figure 4) and were asked to remove their anchor and move prior to us being able to mark the reef for diving. Sure enough, diver inspection again found evidence of more anchor damage on this reef, continuing the trend that was first noted 9 months ago (see Figure 4 in Diggles et al. 2019b). The larger besser fence modules nevertheless are still providing some protection to the edges of the reef, and underwater video of this reef, despite poor visibility, found it was frequented by at least 12 species of finfish including whiptail, happy moments, Gunther's wrasse, yellowfin bream, cardinalfish,

During this sampling period and in previous months the authors have witnessed first hand several boats attempting to anchor directly onto the experimental reefs (e.g. Figure 4). The revised design of the taller, more robust better block fence modules deployed in December 2018 have reduced, but not eliminated, the detrimental effects of anchor damage. Given the heavy fishing effort that is being expended over the restoration site (BK Diggles, personal observations), and the lack of appropriate signage advising boaters not to anchor in the area, it is likely that dozens of anchoring events are occurring over these experimental reefs every week. Anchor damage, rather than lack of recruitment of oysters, is therefore likely to be the major threat to the longevity of restored subtidal shellfish reefs in Pumicestone Passage. Given that signage at boat ramps and educational/awareness campaigns in the local media and community groups have not worked to reduce or eliminate anchoring damage during this trial, the high threat from anchor damage may be reduced by:

- proper signage on the marker buoy advising boaters not to anchor nearby; and/or
- addition of 4 smaller marker buoys at the 4 corners of the area to help boaters to line up the edges of the restoration area so they can avoid it; and/or

- provision of permanent anchor buoys which boaters can tie onto in lieu of using anchors that will damage the reefs.

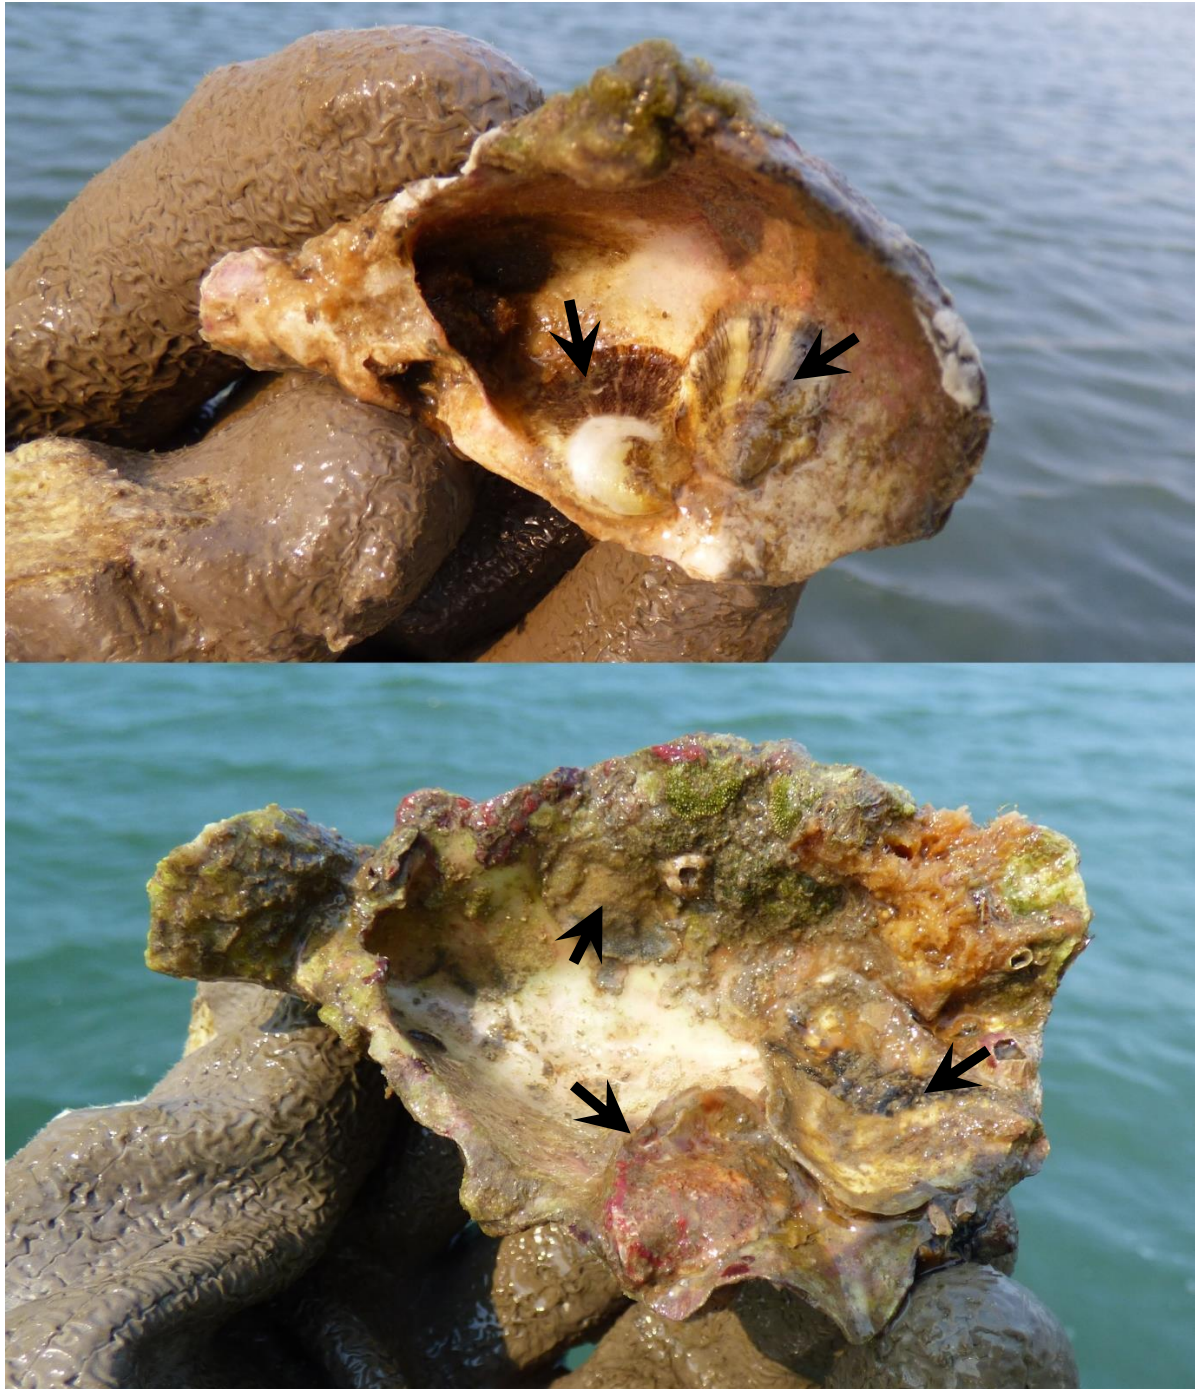
Data from these samples found the northern patch reef (#17) had a mean 59 spat per 100 shells (Table 2), which was similar to, but slightly less than previous samples taken from the same reef after 6 and 9 months (Table 3). This suggests that sedimentation from the geofabric cover is still affecting oyster recruitment and survival. In contrast, the number of spat counted from the sample from the southern patch reef (#18) continued to increase (now 125 spat per 100 shells, see Table 2), indicating further recruitment of not only honeycomb oyster (*Hyotissa* spp.) (which was first noted in the 9 month sampling), but also early season *Saccostrea/Crassostrea* recruitment (Table 3). Shells sampled from reef #18 continued to display significant recruitment of other invertebrates including tunicates, colonial tunicates and coralline algae (Figure 5)

**Figure 5.** Examples of rock oyster spatfall (arrows) and other invertebrate recruitment (coralline algae, barnacles, tunicates) for oyster shells taken from reef #18 after 12 months deployment in Pumicestone Passage.

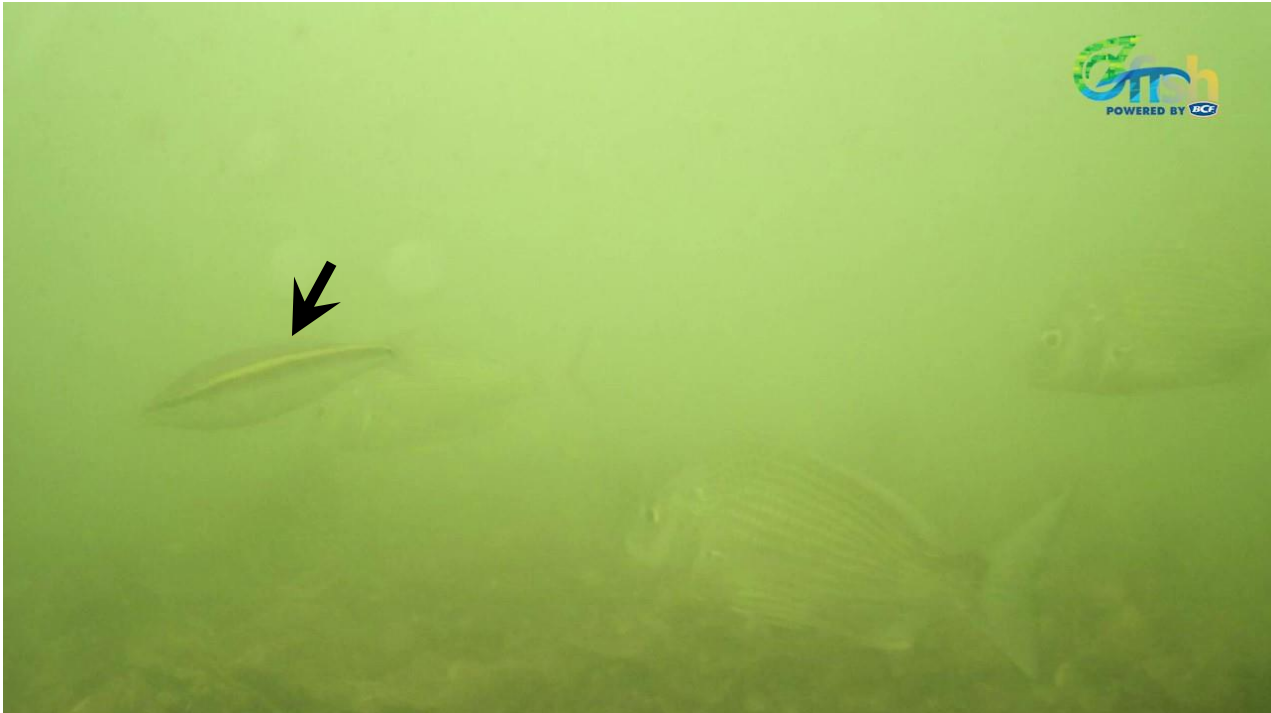
**Figure 6.** Photo from a video of the southern reef (#18) on 22 December 2019 showing a school of yellowfin bream together with a whiptail (arrowed). The 15 minute video showed the reef was being frequented by at least 12 species of finfish (video available at <https://youtu.be/AIiym-mGQrA>).
