# Pumicestone Passage Shellfish Reef Habitat Restoration Project – 9 Month Invertebrate Monitoring

**OzFish Unlimited**

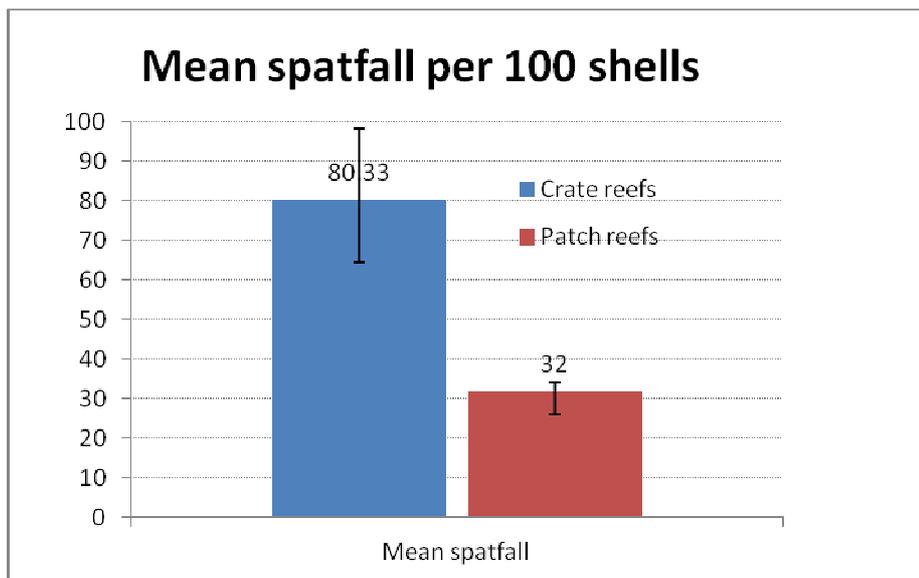
Strong currents prevented divers from having sufficient bottom time to sample shell from all the available crate and patch reef modules (n = 8 in total). There was insufficient time to locate reefs 4 and 11, however, samples of 100 shell were obtained from the other six reef modules, namely module #'s 1,2,6,9,12, and 16. Shells were not available from the BESE modules and these were inspected for general condition only. Spat of *S. glomerata* were observed in samples taken from all modules examined at an average of 56.16 spat counted per 100 shells sampled (Table 1). The mean spatfall from the crate modules examined (crates 1, 6 and 12) was 80.33 spat per 100 shells (range 64-98 spat per 100 shells). In contrast, the average spatfall for the patch reefs examined was much lower at 32 spat per 100 shells (range 28-34, see Table 1, Figure 4).

**Figure 4.** Results for natural *S. glomerata* spatfall on oyster shells collected from crate reef modules and patch reefs after 9 months subtidal deployment in Pumicestone Passage. Spatfall was higher on crate reefs.

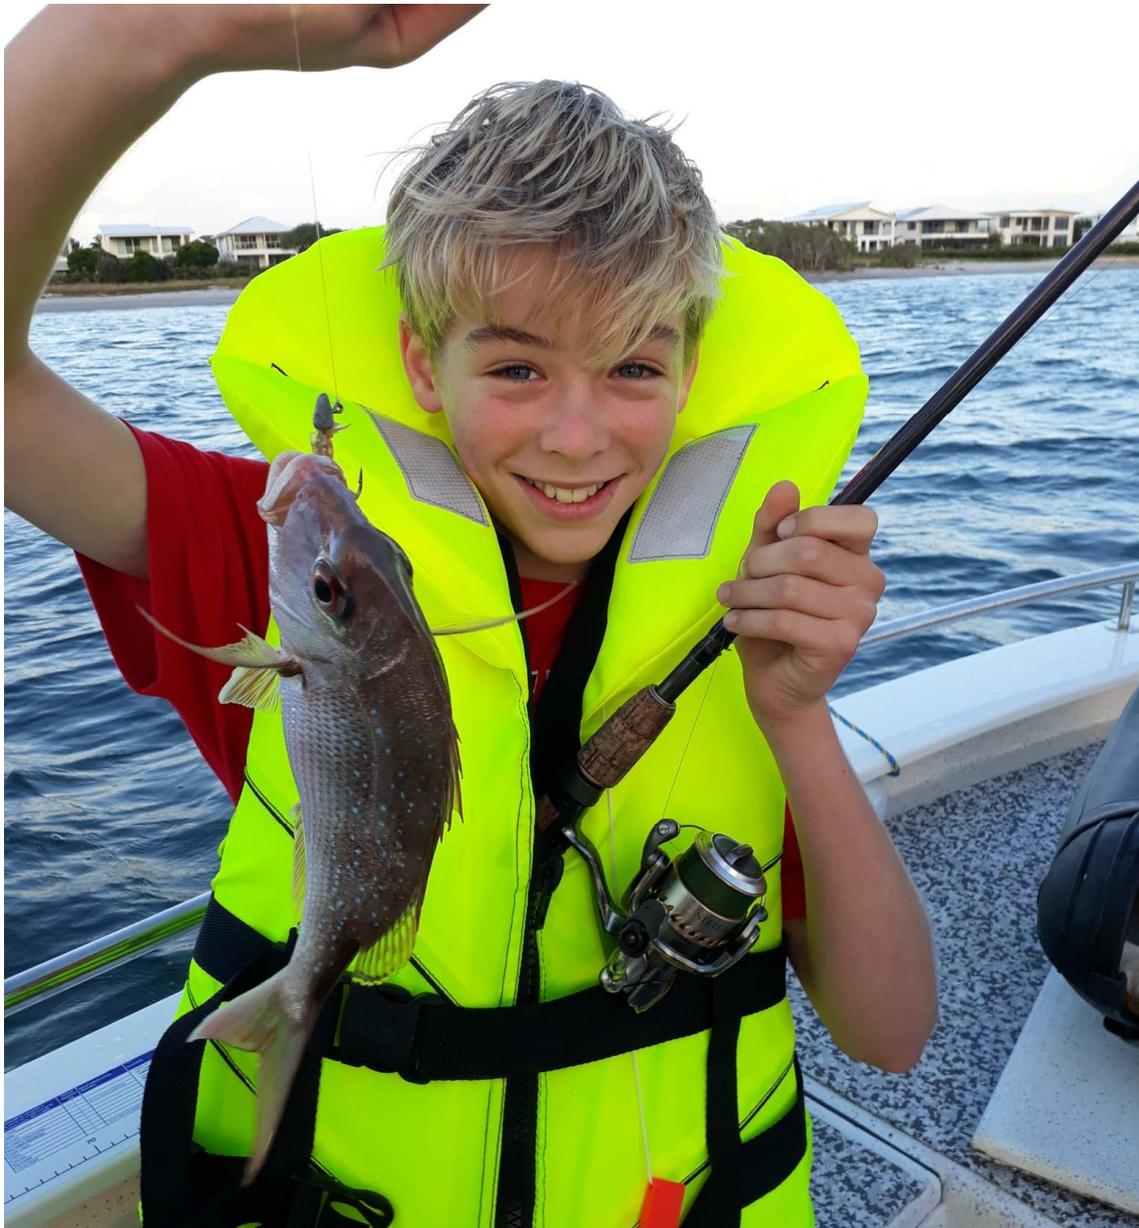
**Figure 16.** Typical undersized snapper captured by a young angler over patch reef #9 in May 2018. This fish was released after the photo was taken.
